NGO “DINARICA” Final Report of Experts on the Project: „Towards the first removal of barriers /dams (on watercourses) in Bosnia and Herzegovina: Livanjsko polje case study“

Mostar, October 2023.

Title of the Project: “Towards the first removal of barriers /dams (on watercourses) in Bosnia and Herzegovina: Livanjsko polje case study”.

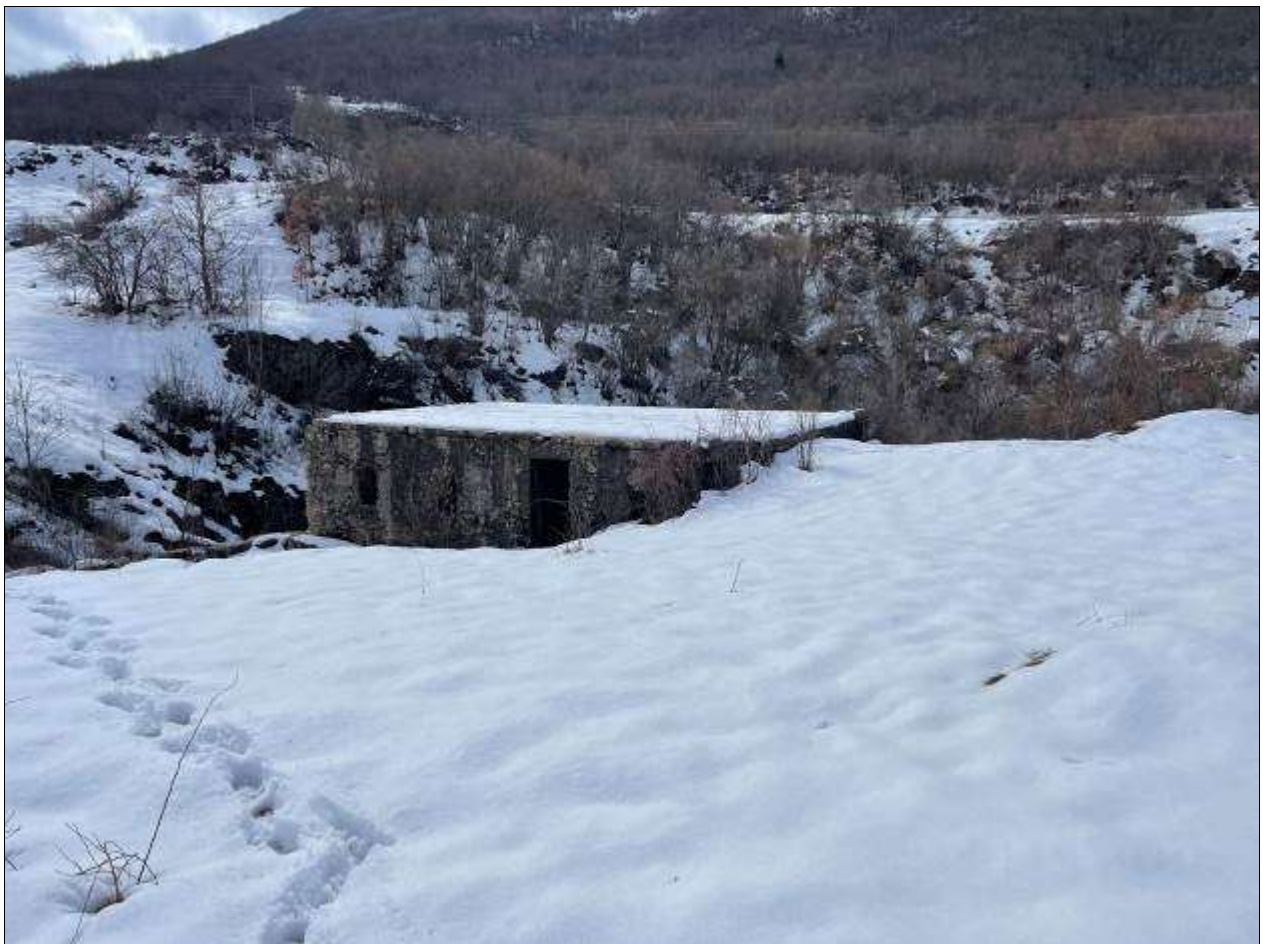
The average height of the walls is approximately 3 meters, with the wall height along the stream being around 8 meters. The average wall thickness is about 50 cm. The structure comprises two main rooms separated by a partition wall, along with a small entrance area providing access to these rooms. There are no remnants of installations or equipment from the former mill, further indicating that the structure has been completely abandoned. An important aspect defining the operational capabilities of the mill is related to hydrological seasons. It can be noted that the structure could not operate during the summer period when the Plovuća River (like most surface watercourses in Livanjsko Polje) completely dries up. Consequently, the structure could only function during the colder (winter) period of the year when this part of Bosnia and Herzegovina experiences the main hydrological peak season

Picture 3. The abandoned mill structure is located directly adjacent to the sinking zone of the Plovuća River.

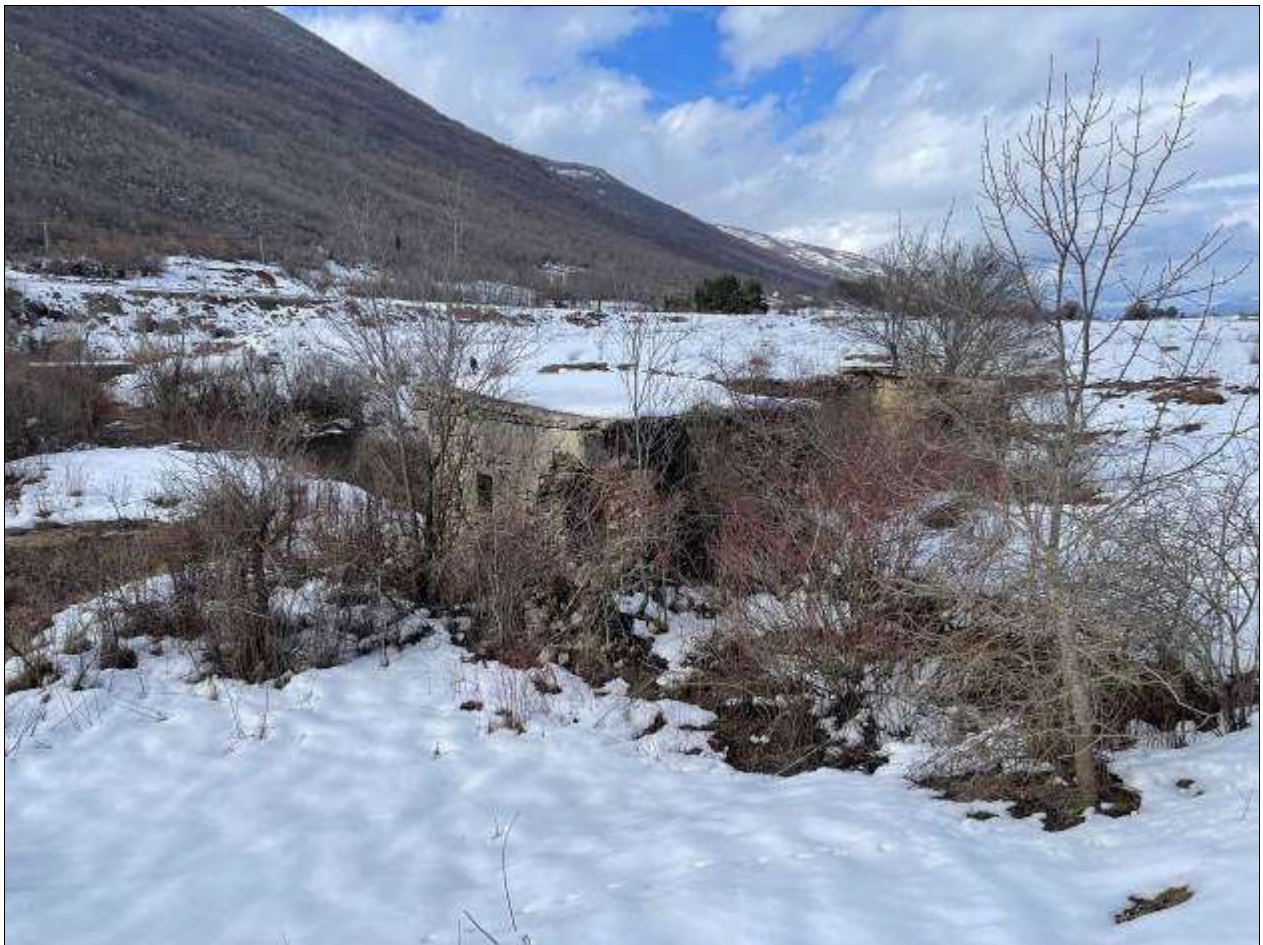
The structure is built directly on the course of the Plovuća River and consists of two parts: a mill structure with a dam and a regulating flap to control the water flow, and a concrete basin, likely used as a fishpond. The structure is in a dilapidated state with visibly destroyed and damaged walls. The roof is completely demolished. The dimensions of the structure are 8 m x 3 m, with an average wall height of 3.5 m. The walls are constructed from masonry stone and significantly damaged. The wooden roof structure of the building is completely destroyed (see Image

Picture 4. The abandoned structure - a mill along the course of the Plovuća River

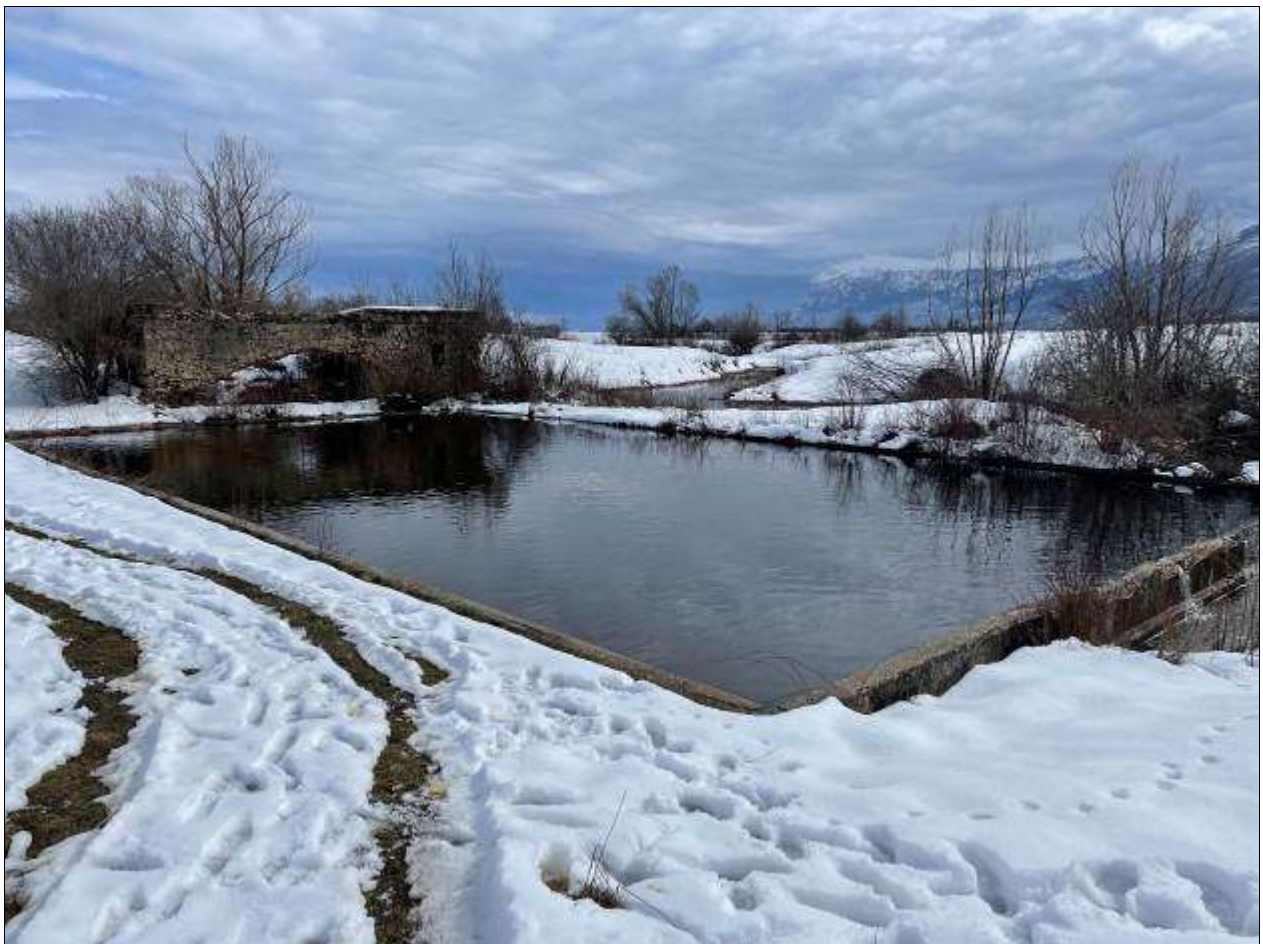
The water passing through the mill was controlled by a flap allowing a flow of approximately 3 m³ and was directly diverted into the pool, whose external walls are also made of masonry stone. The pool is rectangular in shape, with sides measuring 20 m x 10 m, and the wall height is approximately 3.5 m. The basin likely served as a watering hole for livestock. However, the structure has long lost this function due to the construction of the hydropower plant system, which deprived it of water during the summer months when livestock grazing occurs in the field. This is evident from the very poor condition of the walls and the basin's base, which are severely deteriorated. Part of the barrier comprises the foundation of fishponds embedded in the riverbed at a depth of about 1 m. Water from the basin is regulated and released into the downstream part of the Plovuća River.

Picture 5. The removal of the planned pool structure.

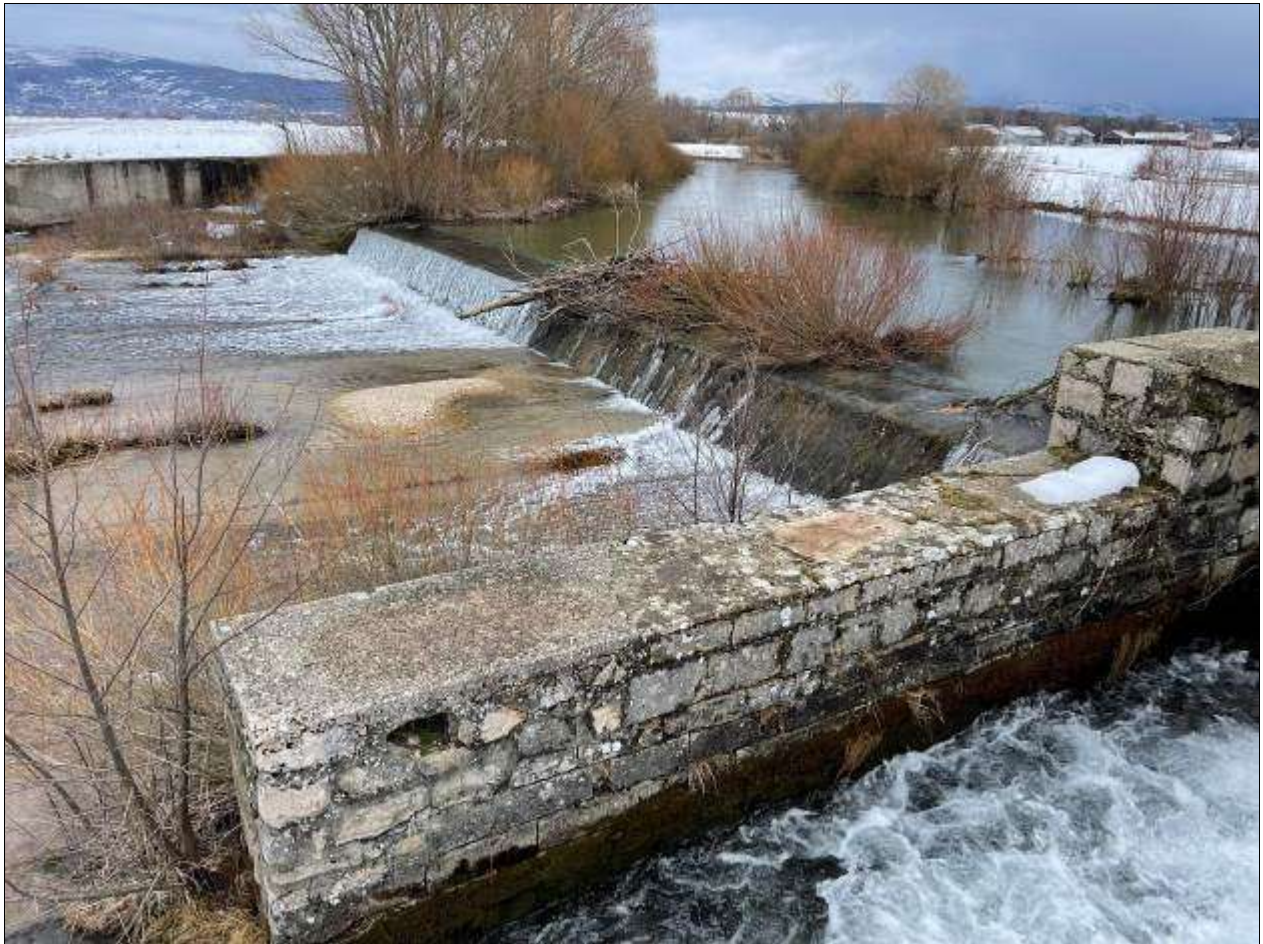
The dam structure represents a concrete barrier built along the entire cross-section profile of the Sturba River's riverbed, with a length of about 50 meters. When observed from a plan view, the barrier has a ribbed structure that serves to create water jets, thereby increasing their kinetic energy. This was intended to generate greater power to turn the blades of watermills that operated the mills. The structure is in a completely dilapidated state and lacks any hydraulic or economic function. The dimensions of this part of the structure are: 50 meters x 12 meters. The height of the structure is approximately 1 meter, with foundations about 1 meter deep. The walls' thickness measures around 80 centimeters. The surface area of this structure is about 490 square meters. The riverbed obstruction led to the formation of a small accumulation lake of overflow type, given that the mentioned barrier is insufficiently high to form a larger accumulation

Picture 10. The Sturba Dam intended for removal.

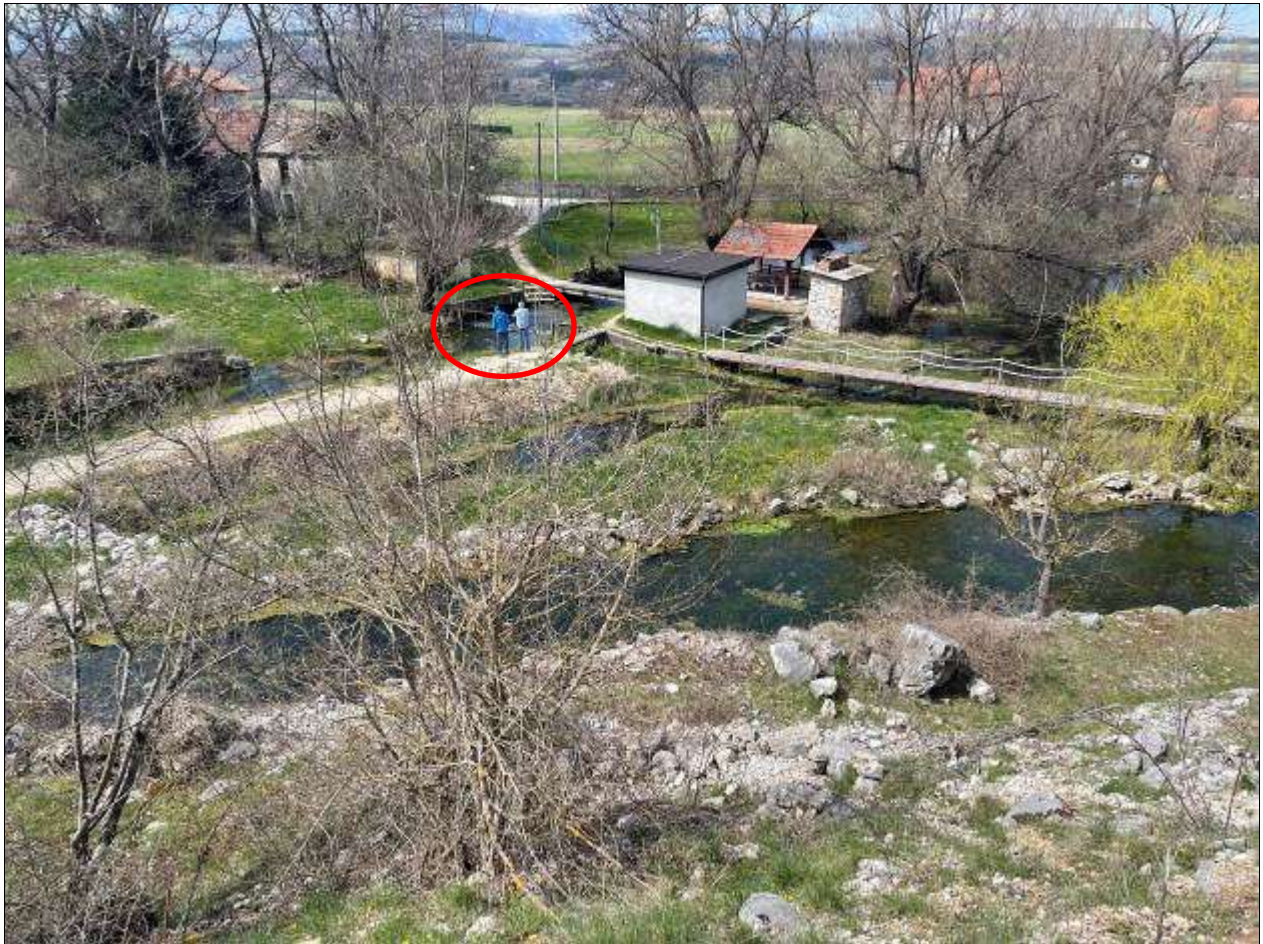
Picture 12. The position of the barrier at the source of the Sturba River (marked by a red circle)

The barrier is made of concrete with foundations buried about 1 meter deep into the riverbed, while the remaining part, around 0.5 meters, is above the streambed.

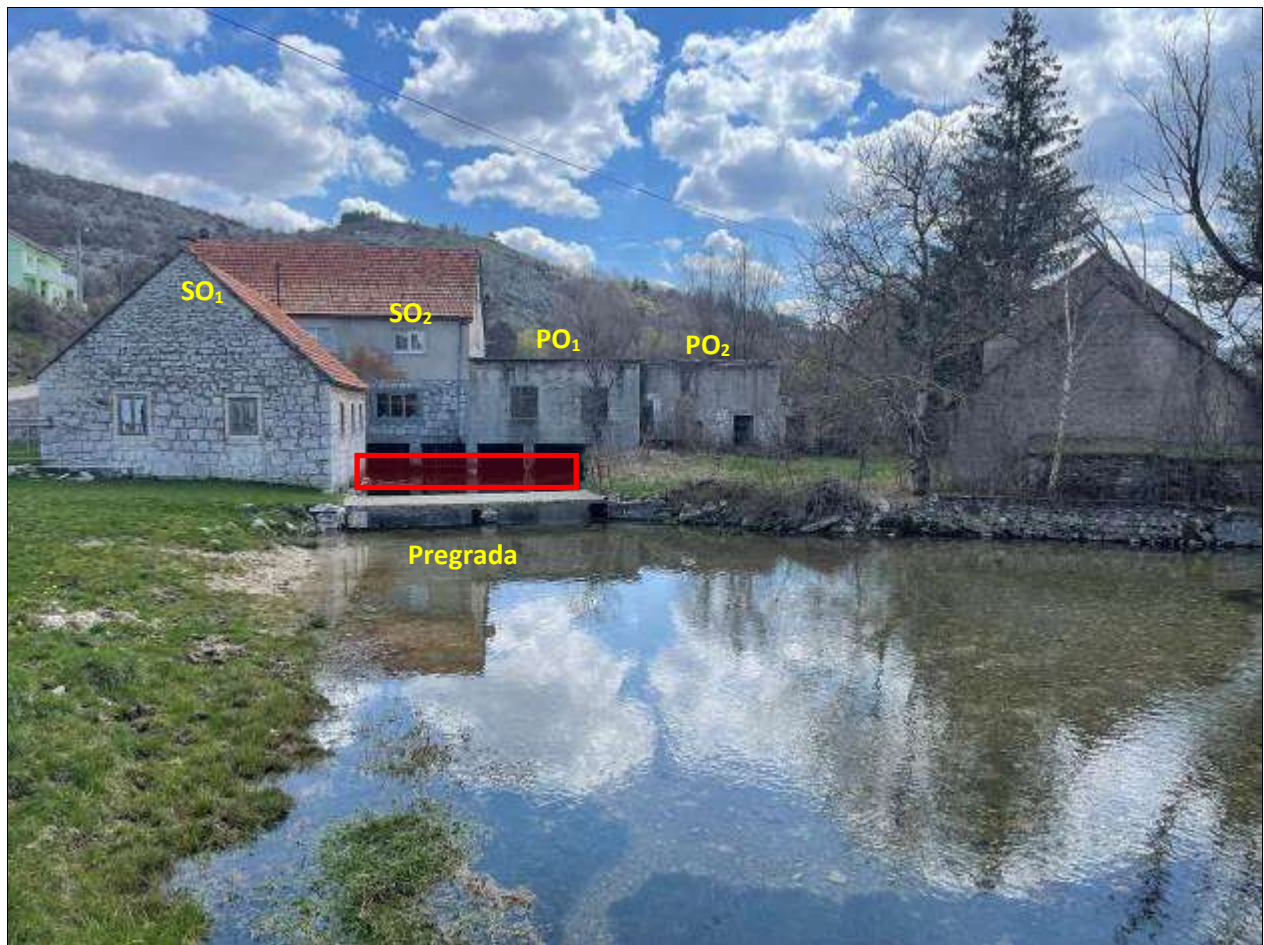
Picture 15. Spatial position of the group of objects obstructing the right branch of the Sturba River in the area of Mljekara Orman. The obstacle in the area of the right branch of the Sturba River belongs to a group of constructed objects with residential function (SO1, SO2). Essentially, these are two buildings that have been reconstructed and adapted for habitation. The first building is single-story, while the second one has two floors, with the ground floor adapted for milling operations and the first floor serving a residential purpose. Apart from residential structures, the group of constructed objects also includes two smaller ground-floor auxiliary buildings (PO1 and PO2), likely used previously as storage spaces for food products produced in conjunction with the milling operations (see figure

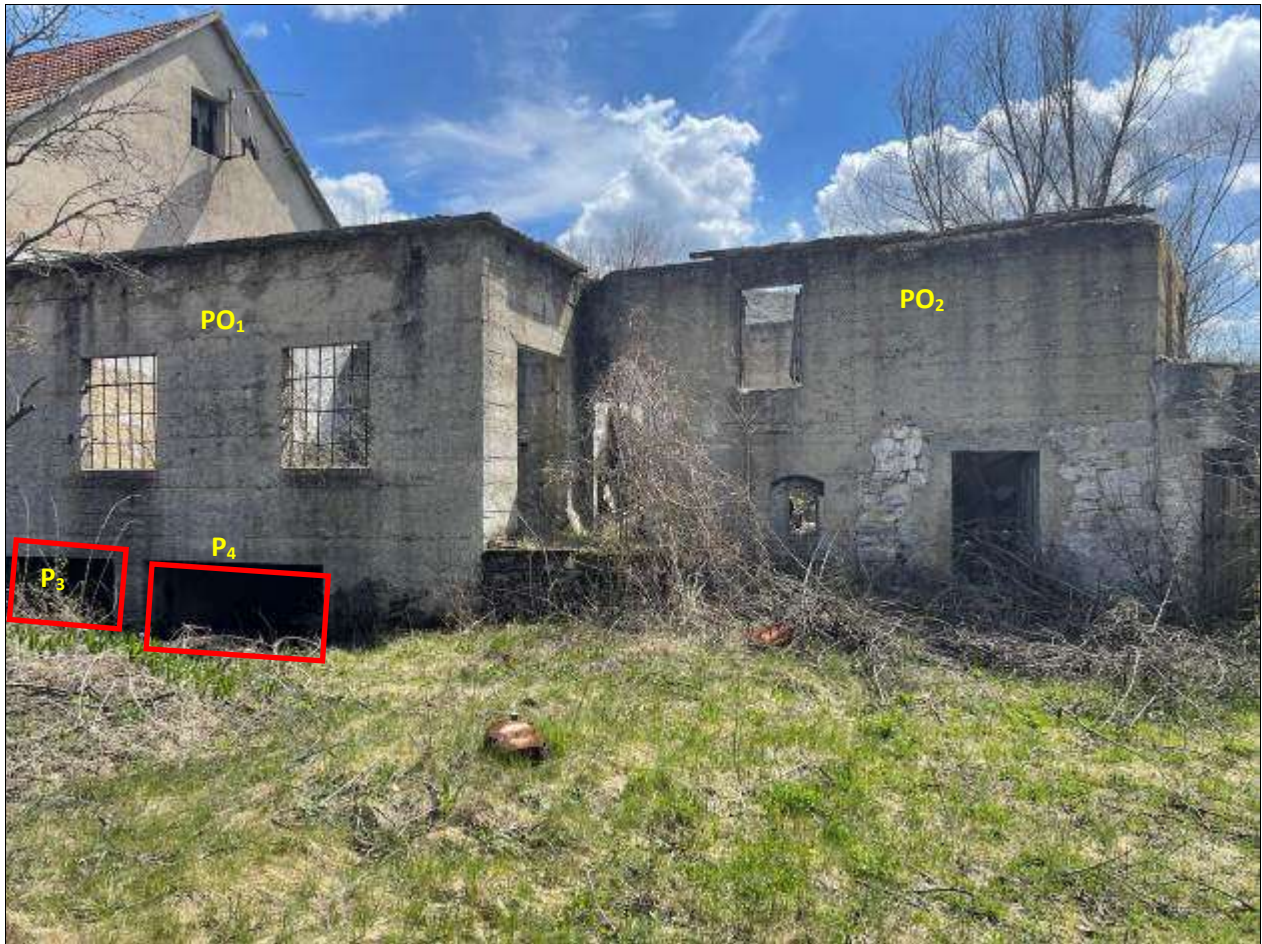
Picture 16. Spatial position of the unreconstructed objects that obstruct the right branch of the Sturba River in the area of Mljekara Orman

The auxiliary buildings, which are built and completely devastated. The walls are approximately 70 cm thick. The first auxiliary building (PO1) has dimensions of 8 m x 7 m x 6 m. On the front side of the first auxiliary building, two smaller window openings are constructed (dimensions: 0.8 m x 1.2 m), while entrance doors are installed on the side. The building is constructed over the left branch of the Sturba River, and obstructive barriers P3 and P4 are built on the supporting walls of the building (see figure 16.). Coordinates of the barrier centroid: $\phi = 43^{\circ}46'33.93''\text{N}$; $\lambda = 17^{\circ} 01'13.91''\text{E}$; $H = 737 \text{ m a.s.l.}$

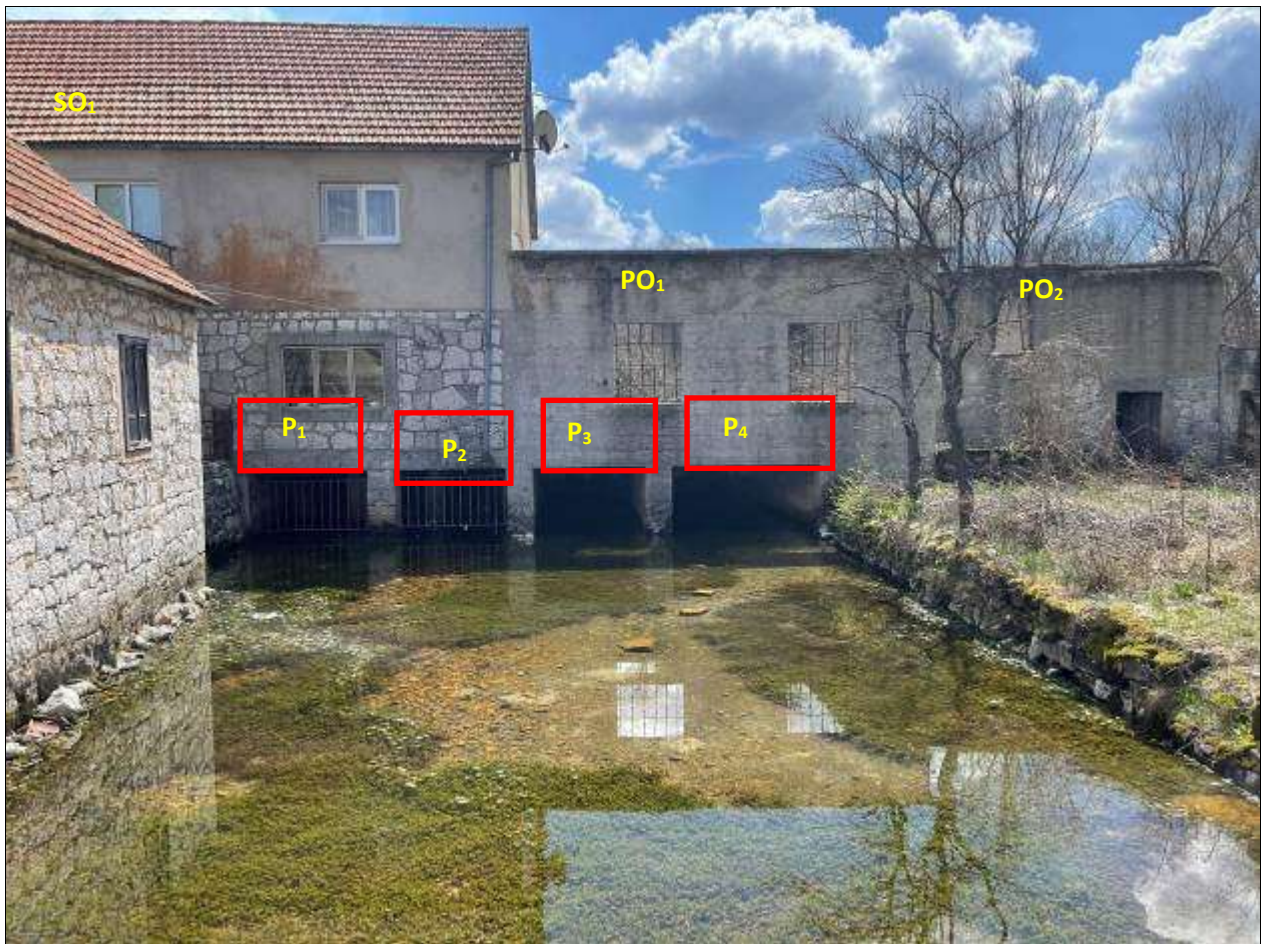
The barriers on this section of the Sturba stream are constructed on the foundations of residential building 2 and auxiliary building 1. The foundations of these buildings are concrete, buried in the ground at a depth of approximately 1 m. The constructed barrier does not form a single spatial unit; rather, it divides into four separate spatial compartments through the load-bearing walls of both structures (see figure 17)

Picture 17. The spatial position of the barriers built between the load-bearing walls in part of residential building 2 (the first two barriers) and the first auxiliary structure (the remaining two barriers).

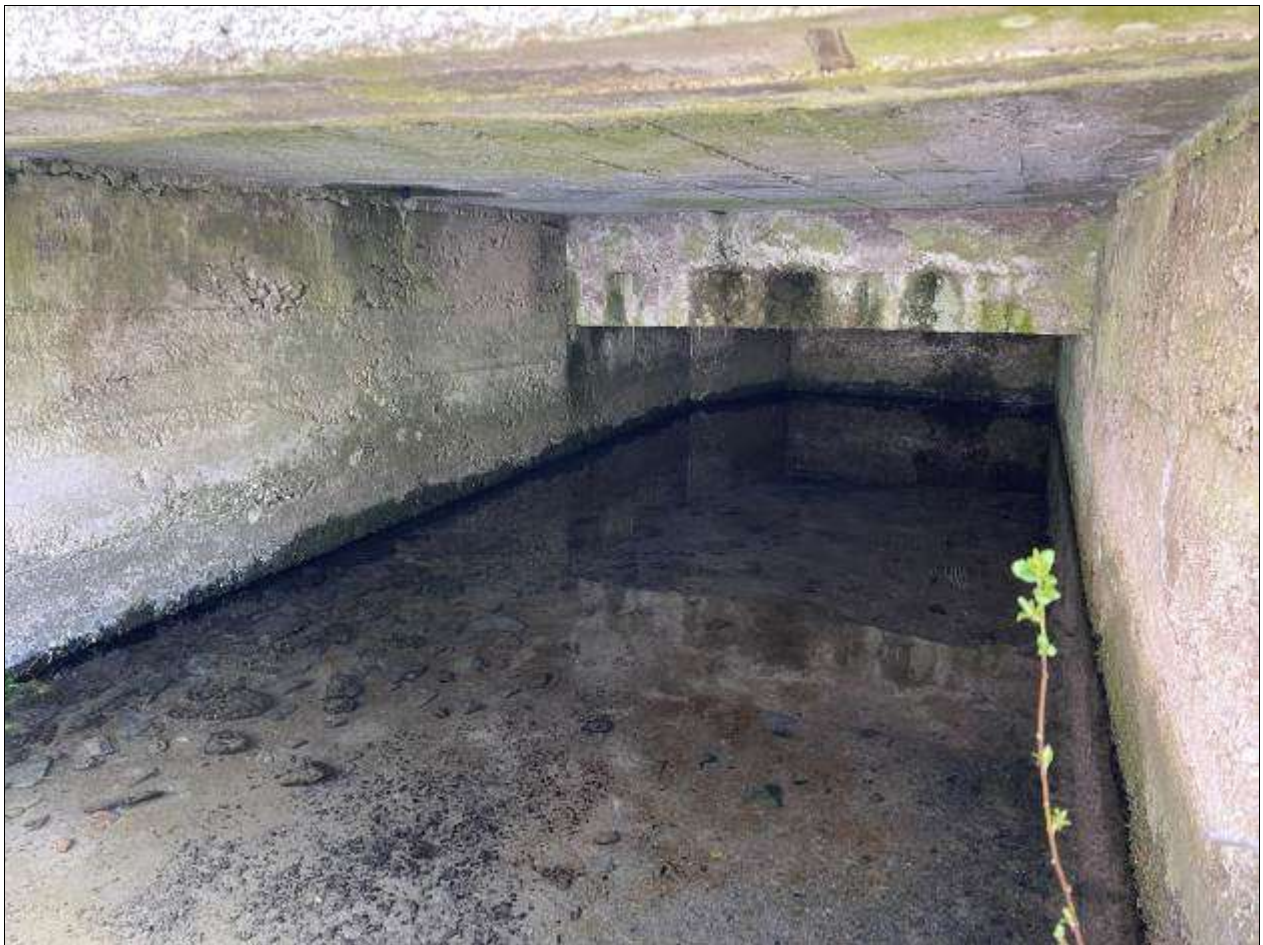
The removal barriers are constructed between the rear parts of the load-bearing walls of the buildings (see Figure 19). These barriers are made of concrete and completely seal off the entire opening between the load-bearing walls. Consequently, the right branch of the Sturba River is entirely blocked, preventing natural drainage. The barriers have the following dimensions: 4 m x 8 m x 1 m. The thickness of the load-bearing concrete walls is approximately 1 m, while the foundation depth of the load-bearing walls of the barriers is around 1 m

Slika 20. View of the rear part of the load-bearing wall in auxiliary building 1, where barrier no. 4 for removal is constructed.

removal of the above-ground and below-ground parts of the load-bearing walls between the first and fourth barriers. The significant contribution to ensuring unimpeded flow in the right branch of the Sturba River involves demolishing both devastated auxiliary buildings. This process would completely free the left section of the Sturba River for uninterrupted natural flow of both water masses and the migration of aquatic and semi-aquatic organisms

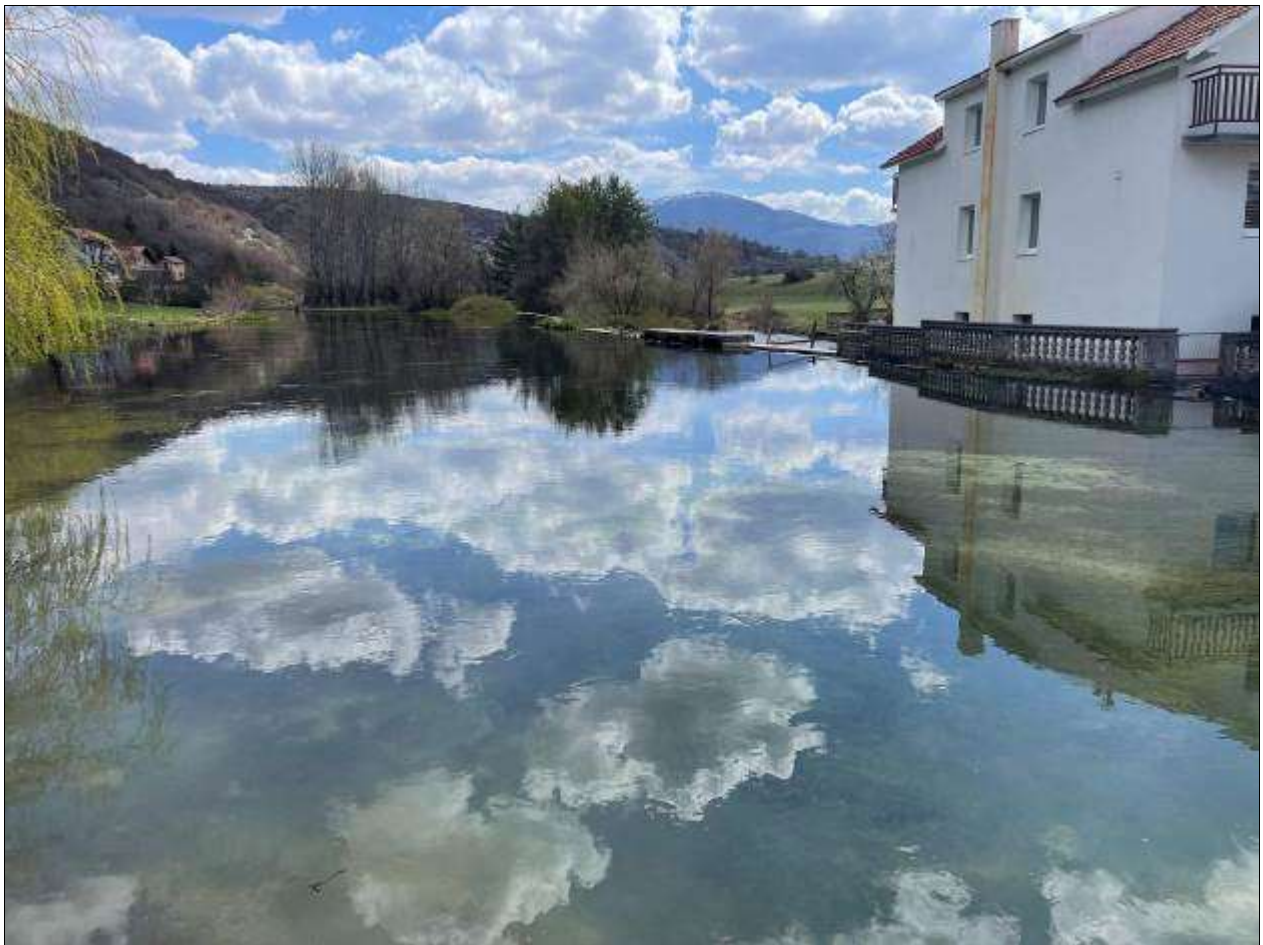
Figure 23. The water surface of the artificial reservoir formed by damming the flow of the Sturba River in the area of Keselj village.

By removing the mentioned barrier, the Sturba River would be restored to its natural state, reinstating the hydrological regime of the river. Additionally, the removal of the barrier would enable unobstructed migration for ichthyofauna and other native species inhabiting the Sturba River. The restoration to its natural state would also revive its significant role as a habitat for migratory bird species during the spring and autumn migration seasons from Northern and Central Europe to North Africa and vice versa.

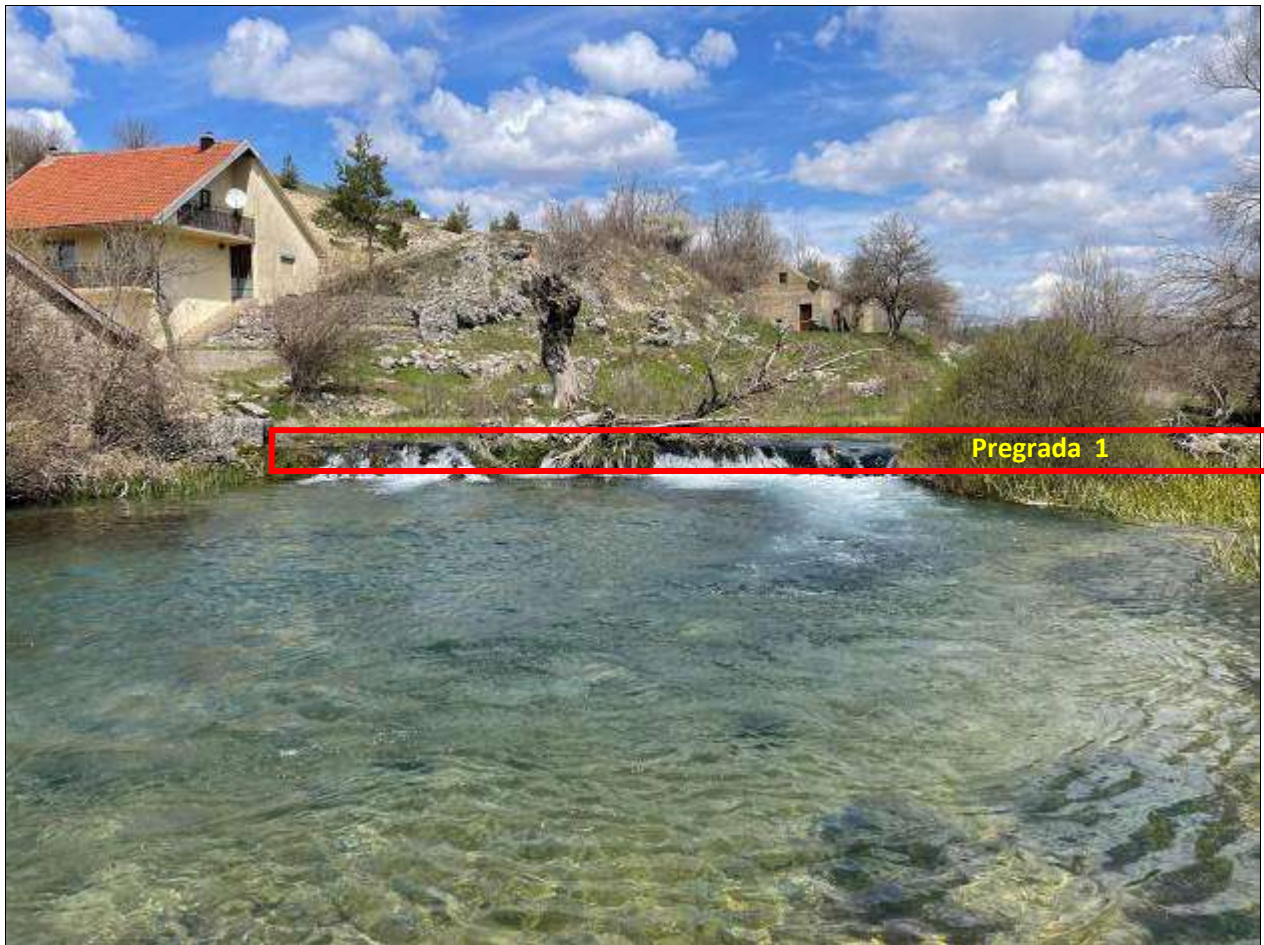
Figure 28. Spatial position of the first part of the barrier on the Sturba River (next to Kelavin Mill)

The first barrier diverts part of the Sturba River's water towards a smaller constructed channel where the mill building is located. The channel is approximately 5 meters wide, increasing the speed of the water mass and its kinetic energy, which propels the mill wheel blades. With the first barrier, a small accumulation is formed, allowing excess water (during periods of maximum rainfall) to overflow into the natural riverbed. During periods of minimal rainfall (July - September), much of the natural flow is redirected by the barrier into the channel for the mills. During this period, the Sturba River in the accumulation area flows very slowly, creating necessary conditions for eutrophication and the development of semi-aquatic vegetation. This is one of the main reasons why woody vegetation such as black willow and black alder subsequently grew around the barrier. Among the woody vegetation, tertiary vegetation comprising shrubs (in their early developmental stages) and tall grasses from the mesophilic meadow communities of the Livanjsko Polje have developed..

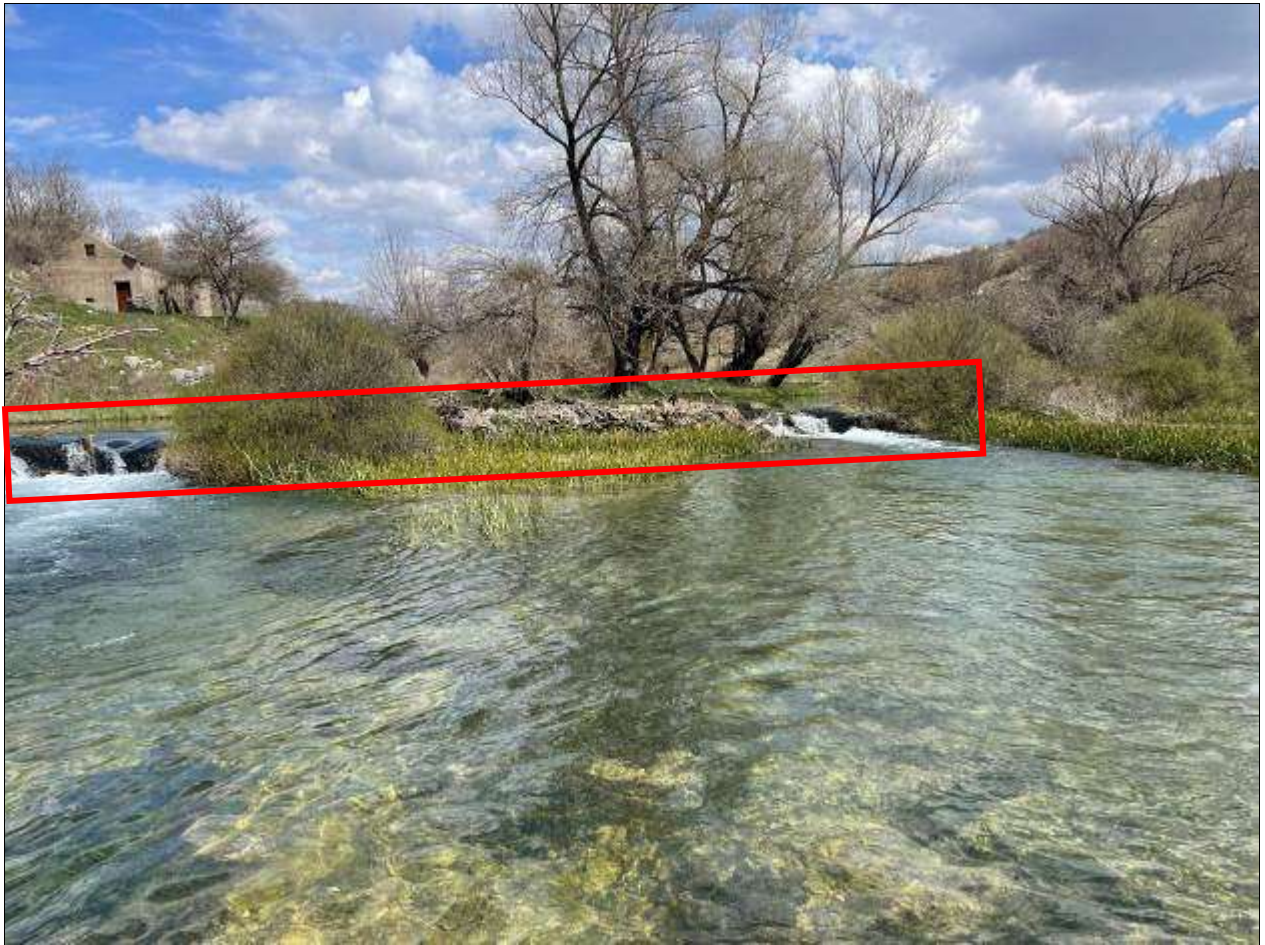
Slika 29. Spatial position of the right part of the first barrier overgrown by successions of black willow and black alder communities and their early developmental stages of shrubs.

In the central and left part of the first barrier, outlets have been built through which the excess water from the accumulation spills into the downstream section of the Sturba streambed. The second barrier is constructed in the right section of the riverbed, encompassing the stretch from Kelavin's mill to the pedestrian bridge. With this barrier, the inflow channel is separated from the Sturba stream, from Kelavin's mill to the bridge (where the channel reconnects to the river - see Figure 30). The length of the second barrier exceeds 40 meters. It is also constructed from larger stones with cement binding, with an above-water part height of about 1.0 meter. The foundation depth of the second barrier reaches up to 1.0 meter while its width extends up to 1.5 meters.

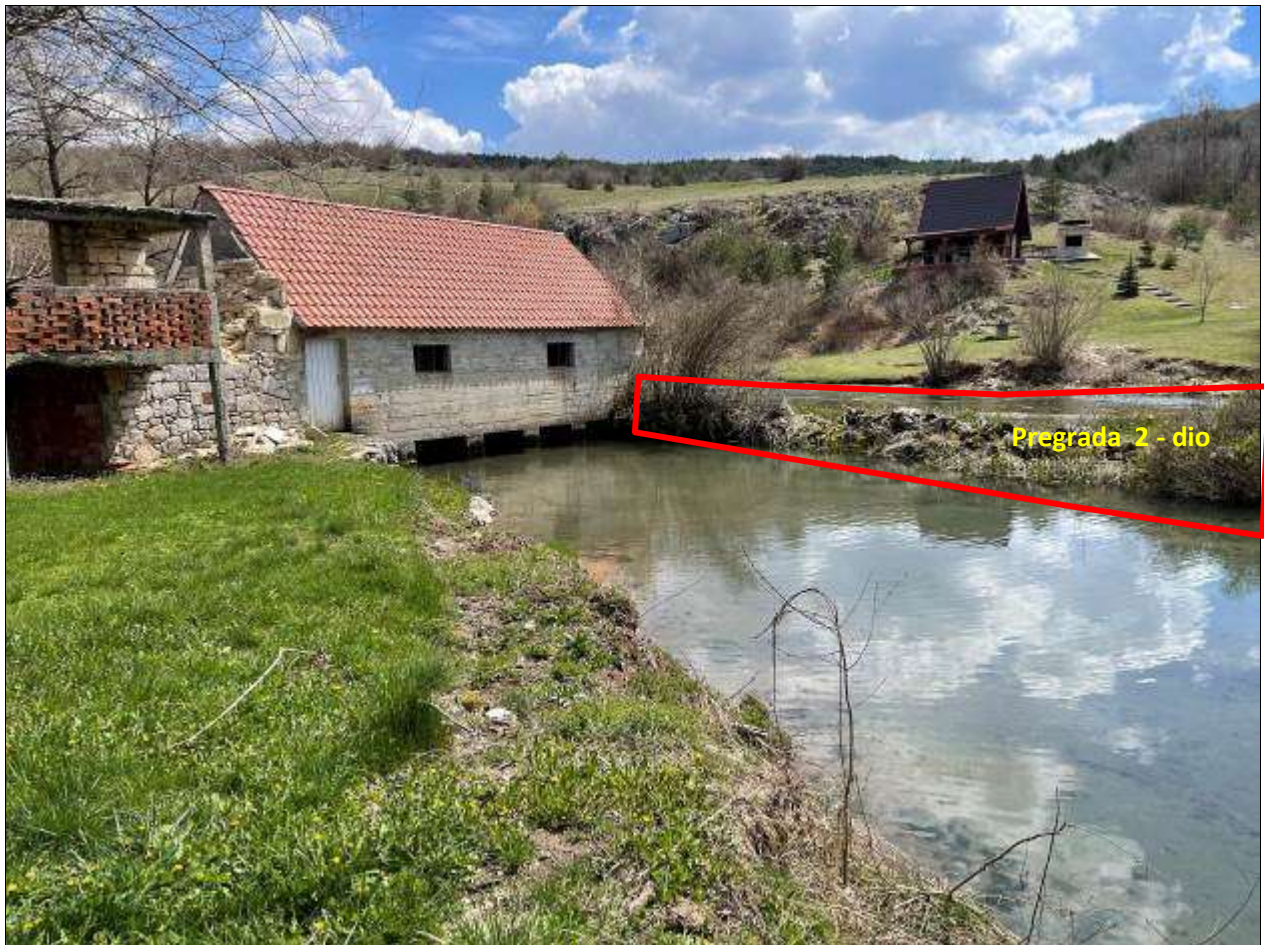
Figure 30. The part of the canal downstream from Kelavin's Mill with the initial section of the second barrier planned for removal

During an external inspection of the mill, four barriers or mini-turbines that power the millstones within the mill building were identified. These concrete barriers also slow down the water flow, contributing to changes in its fundamental physical and chemical characteristics, significantly reducing the ecological status and ecological category of the Sturba river in this section. Specifically, the formed mini-accumulation and ponding of water during the summer months induce the development of eutrophication conditions, altering the qualitative and quantitative composition of natural aquatic and semi-aquatic ecosystems that exist under unchanged hydrological regimes. Additionally, eutrophication conditions spread both upstream and downstream during the summer months, negatively impacting

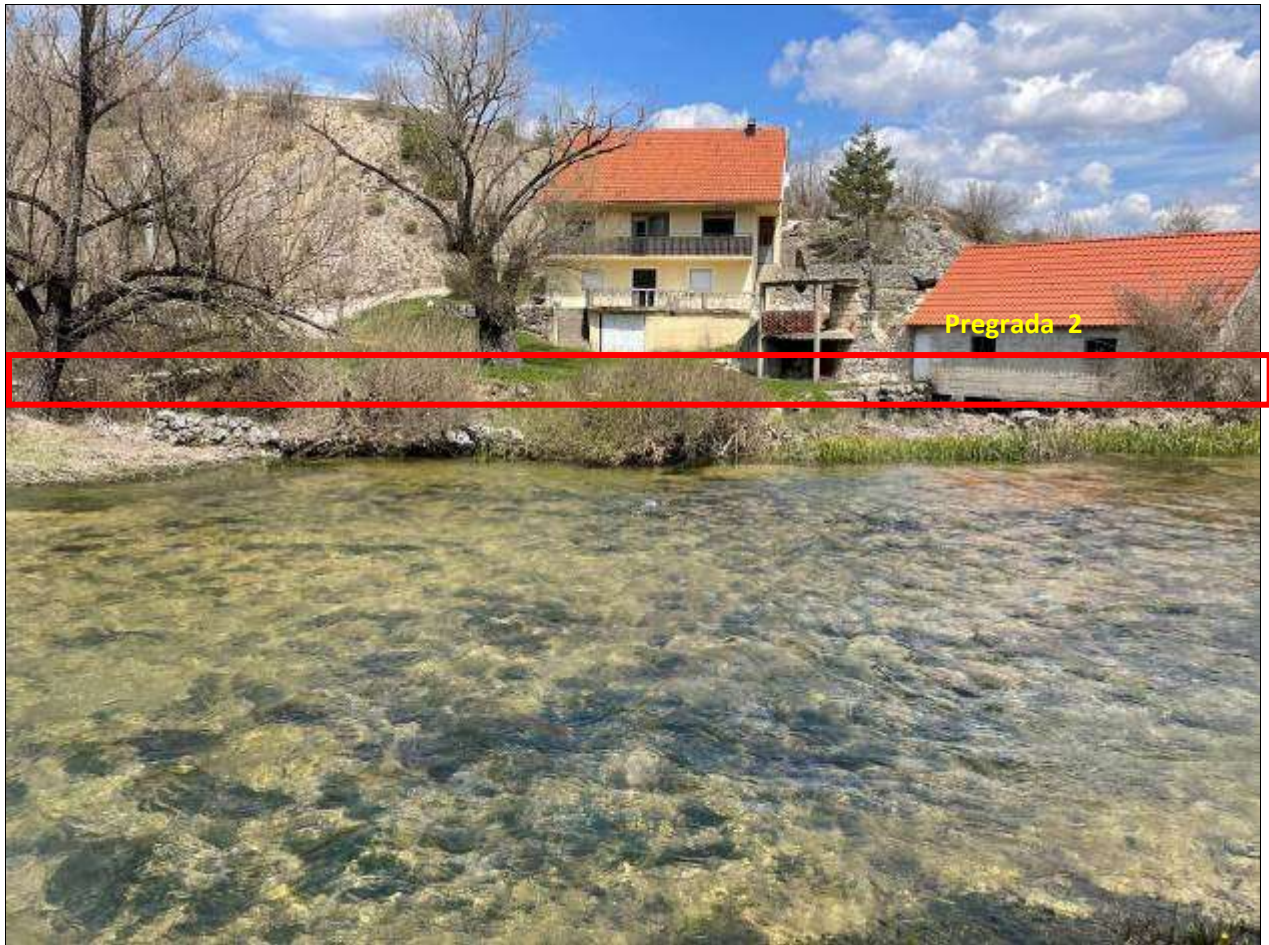
Figure 31. The spatial position of the second barrier, also overgrown by the successions of communities of black willow and black alder in their early developmental stages as shrubs..

Removing obstacles would also mitigate the negative impact of residential and economic facilities directing most of their wastewater into the Sturba River. The structure of wastewater mainly comprises organic waste, significantly increasing the share of phosphorus, ammonia, and nitrogen, as well as chemical elements and compounds that significantly contribute to increased water eutrophication in conditions of elevated temperatures in slow-flowing water

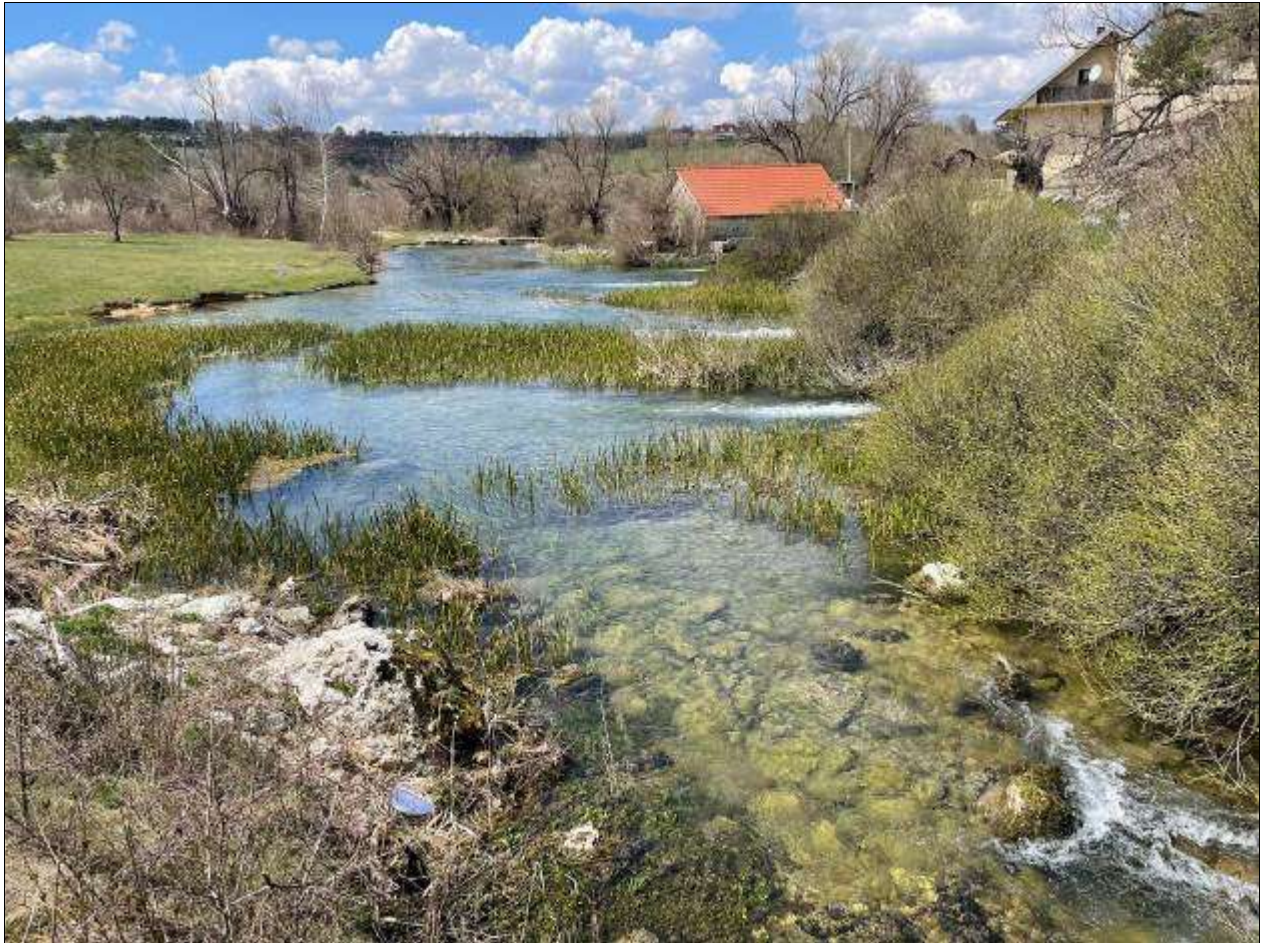
Figure 32. The natural part of the Sturba River exhibits reduced water levels due to diverting a significant portion of the water into the channel towards the Kelavin mill. This situation creates favorable conditions for the development of eutrophication and associated types of herbaceous semi-bog vegetation..

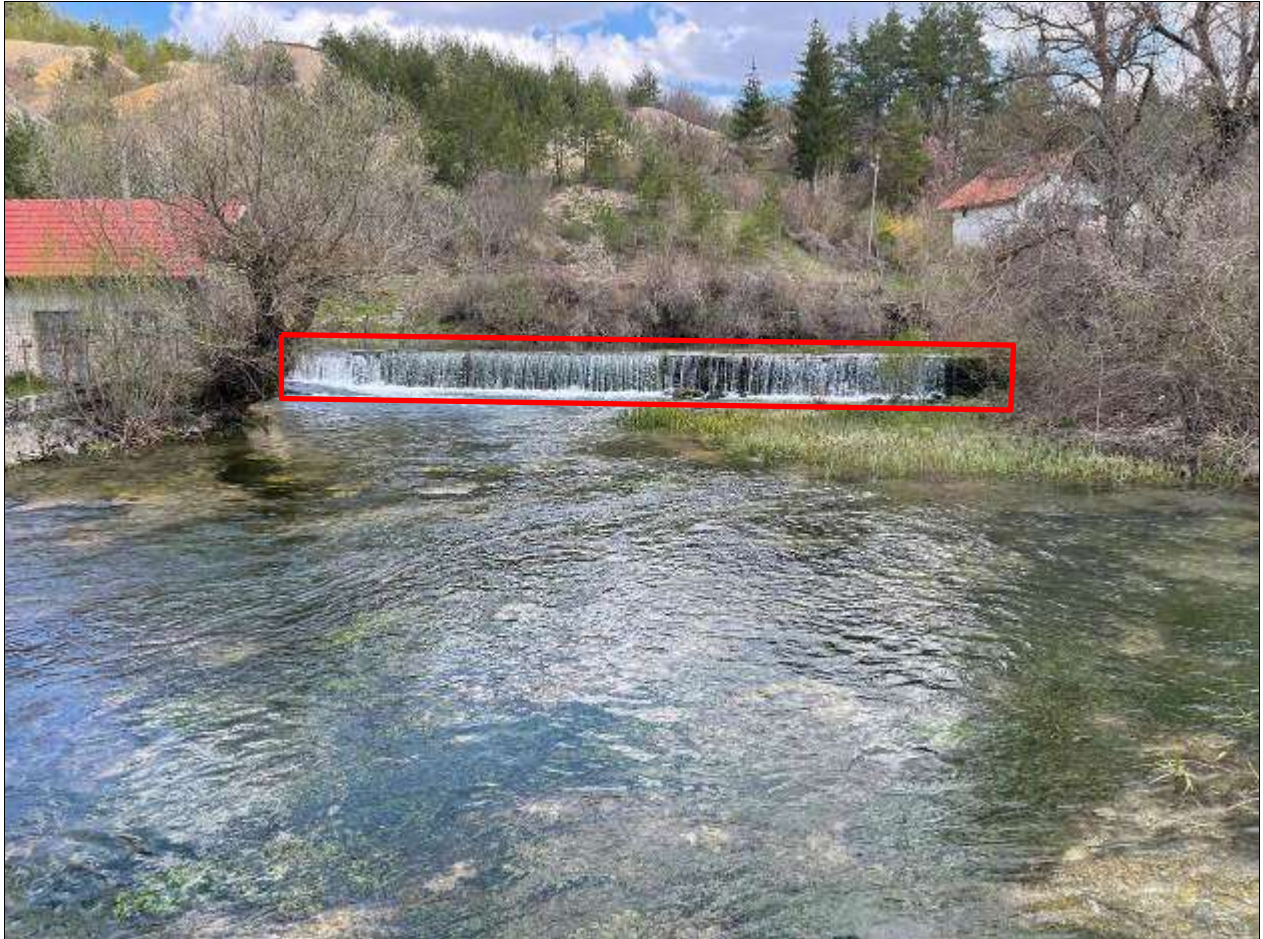
Slika 33. Dio pregrade na toku rijeke Sturbe u zoni Ćurića mlina.

The length of the dam is about 53 meters, its width approximately 2 meters, covering a total area of around 150 square meters of the riverbed. The height of the dam, including its foundation, is about 3 meters, with a base height of around 1.5 meters. The dam is constructed from concrete in combination with stone (see images 34 and 35).
