NGO “DINARICA” Final Report of Experts on the Project: „Towards the first removal of barriers /dams (on watercourses) in Bosnia and Herzegovina: Livanjsko polje case study“

Mostar, October 2023.

Title of the Project: “Towards the first removal of barriers /dams (on watercourses) in Bosnia and Herzegovina: Livanjsko polje case study”.

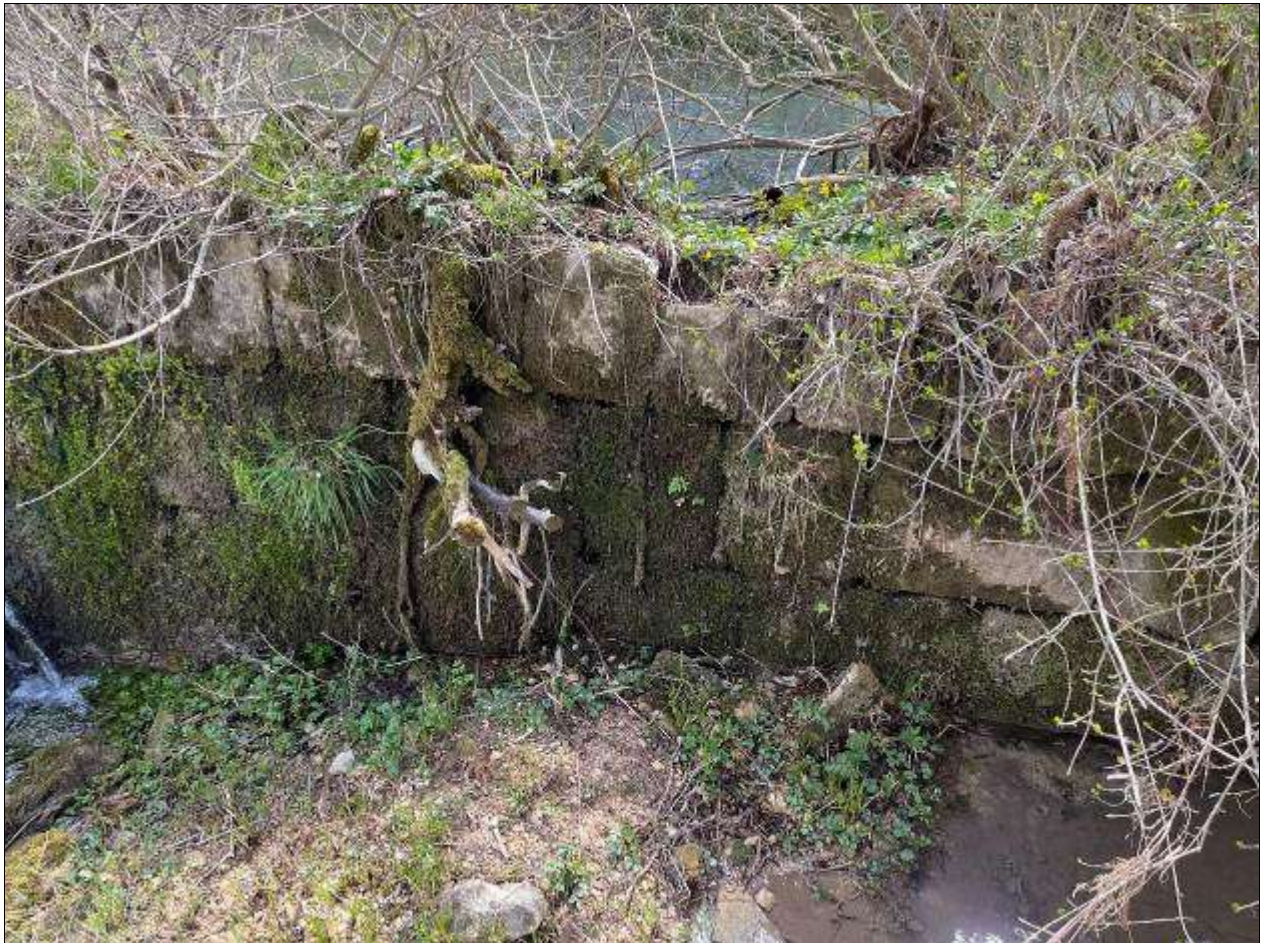
Slika 40. part of the walDonji Golubić 2.

Additionally, as evident in figure 40, both the sub-structure and the embankment are covered in shrub vegetation, predominantly willow and sporadic areas of dogwood, which successively alternate with grasses and other weed species. The image also highlights that due to prolonged lack of maintenance, the wall at the foundation level is indeed allowing water seepage from the riverbed. Consequently, it is realistically expected that there will be an erosion of the wall in the foreseeable future (see figure 41). Measurements taken during the field survey have determined that the total length of the concrete (masonry) barrier amounts to around 24 meters. The overall height of the wall is approximately 2.0 meters, with the foundations measuring about 0.5 meters, and the above-ground portion standing at roughly 1.5 meters.

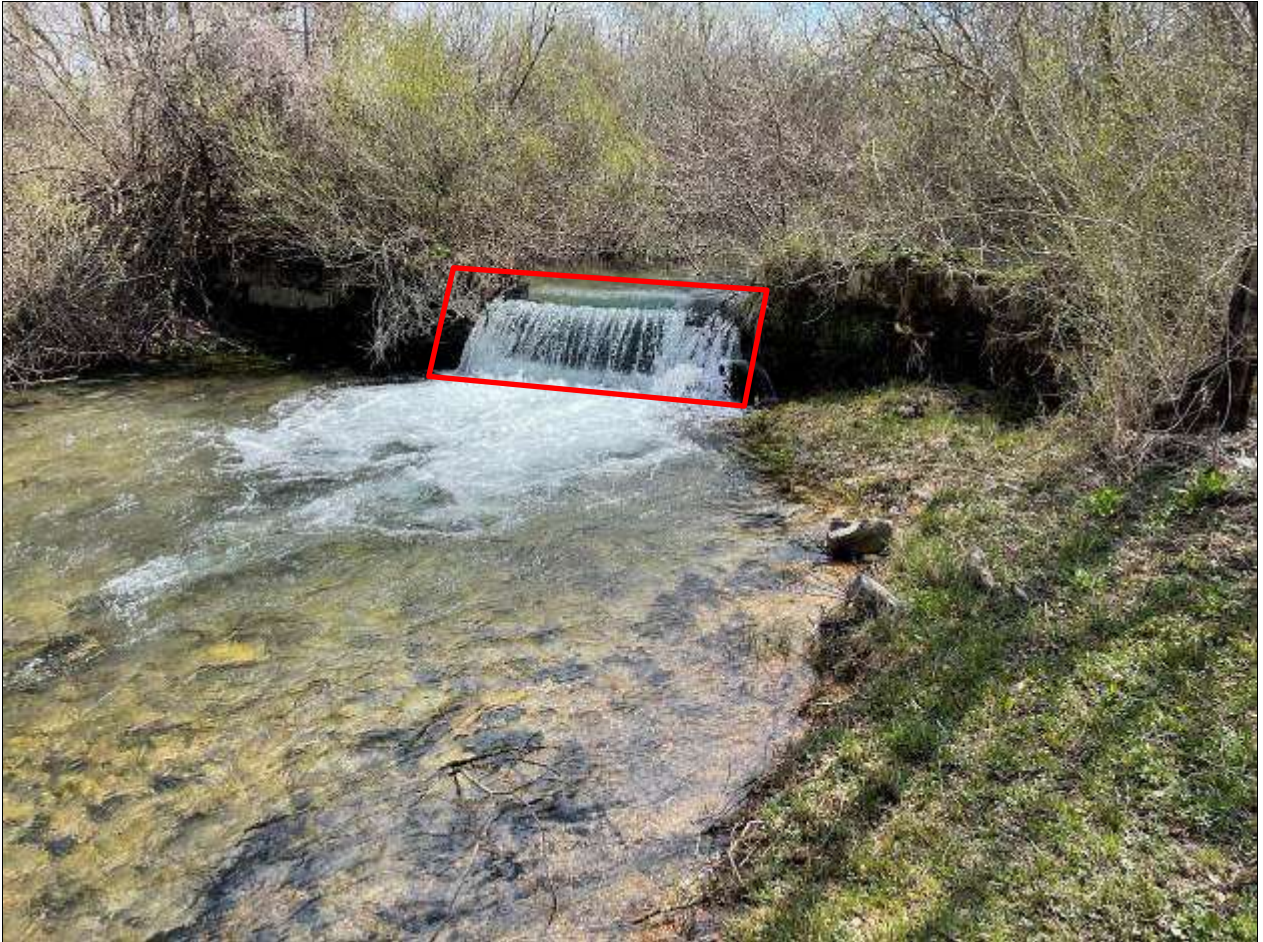
Figure 42..

During fieldwork, it was observed that the earthen embankment and supporting wall were constructed on the left side of the barrier, extending for approximately 5 meters. Similar to the described embankment and supporting wall on the right side, these structures have also been significantly damaged and have largely lost their primary water protection function.

Considering the mentioned issues, it can be confidently stated that the entire described water protection infrastructure has suffered substantial damage and, as a result, does not fulfill its primary hydraulic function. Consequently, the research team is of the opinion that the entire constructed barrier should be removed to restore this section of the Sturba River to its natural hydrological

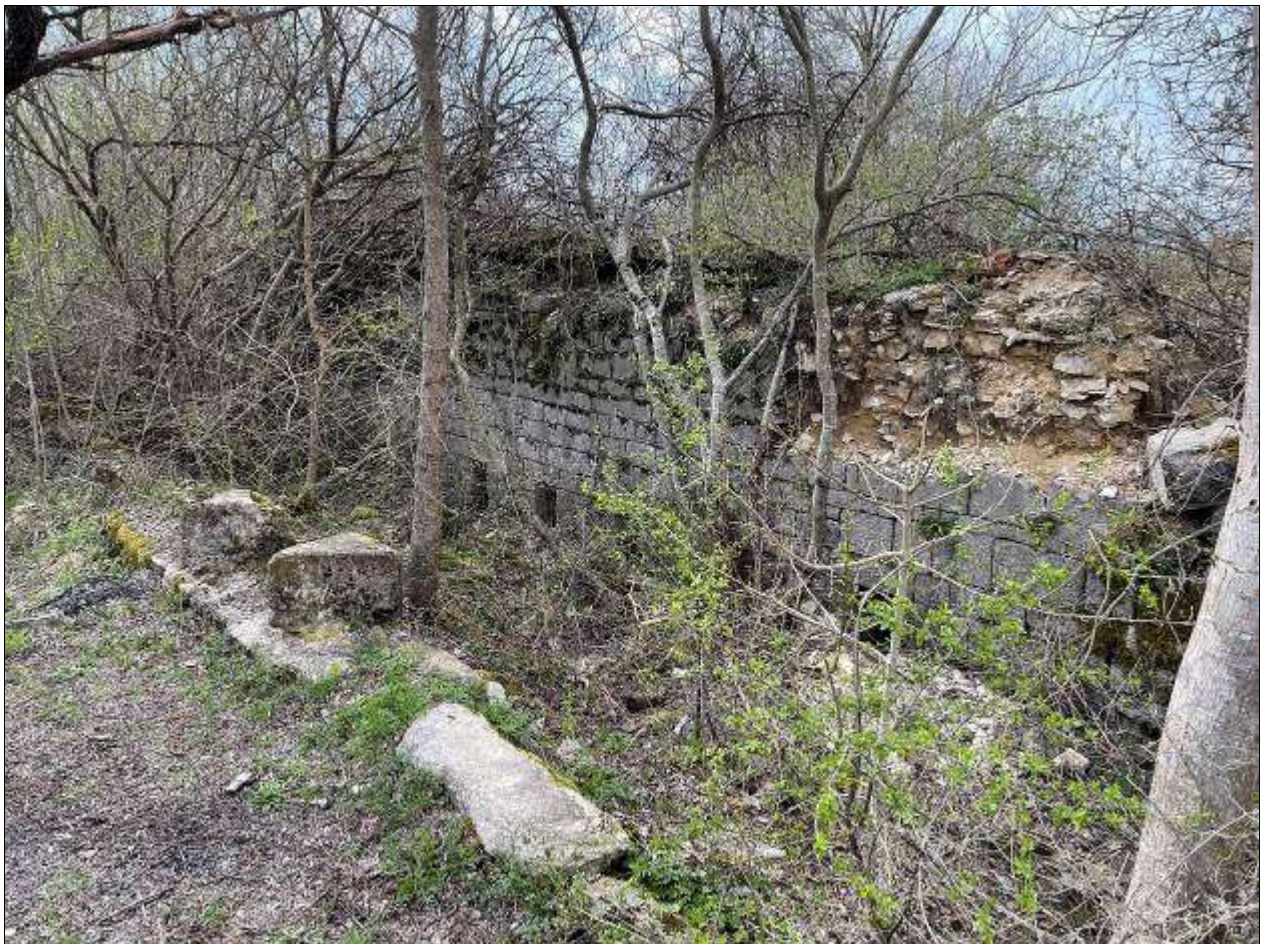
Figure 34 The ruins of the former building (mill) with stone weirs used to direct water to the wooden turbines of the mills.

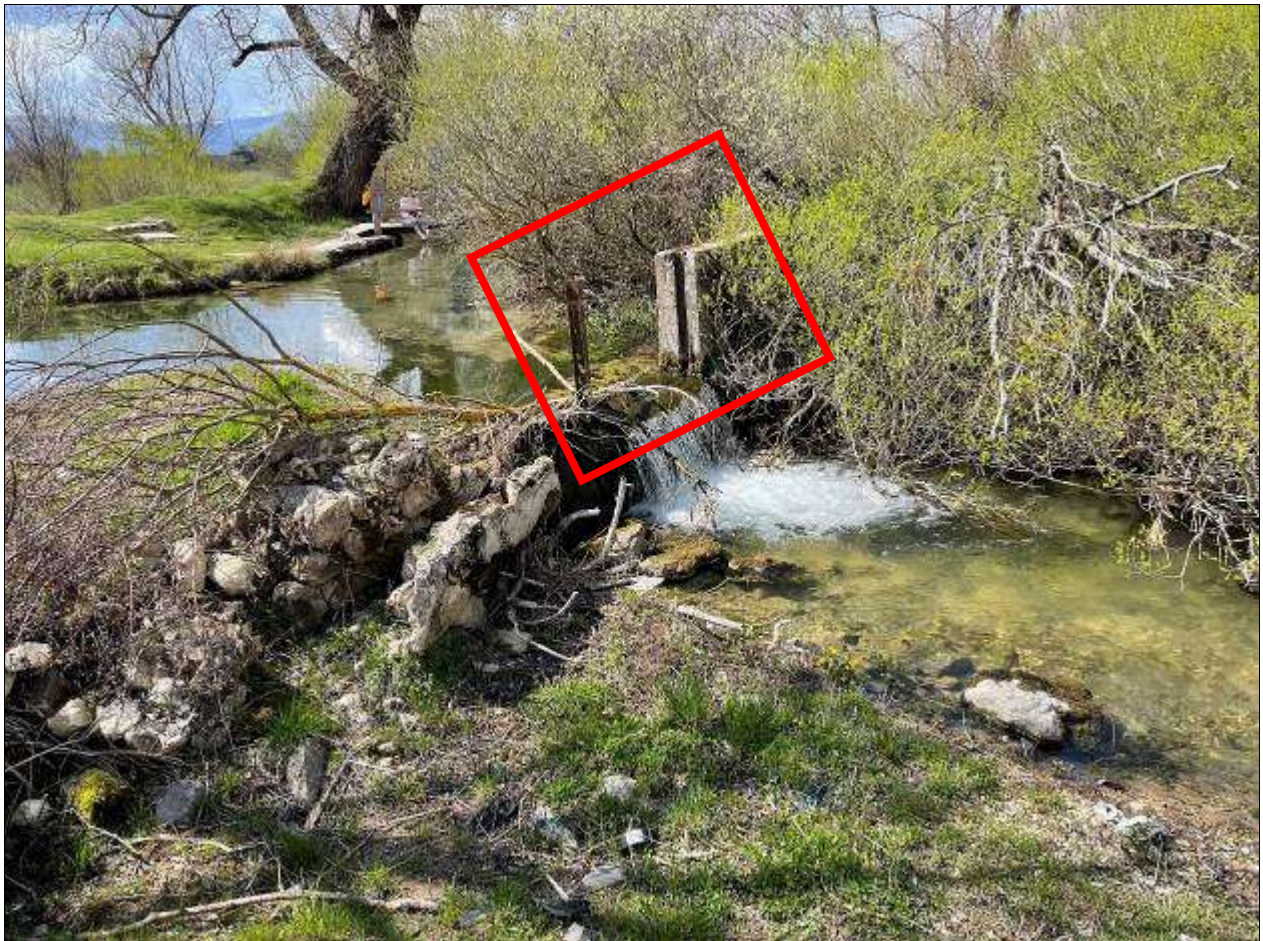
The weir, however, due to decades of disuse and the damage caused by water action, is out of operation, and water overflows over the upper base of the weir (Image 45). The length of the weir (sluice) for water level regulation is about 3.5 meters. The weir is built on a concrete base with dimensions of 3.5 meters x 1.0 meter x 2.0 meters. The height of the above-ground part of the weir is about 1.5 meters, while the foundation has a depth of about 0.5 meters

Slika 45. Prostorni položaj ustave u odnosu na odvodni kanal.

The completed field survey confirmed that the mill structure, for which the drainage channel was originally constructed, is completely demolished, and the former hydraulic infrastructure is not preserved. The weir structure with the weir itself is also entirely devastated and no longer serves the purpose of regulating water in the drainage channel. Considering these noted facts, it can be affirmed that the observed remains of the former weir structure with the weir and the supporting concrete wall should be removed to restore the course of the Sturba River in this section to its original natural state

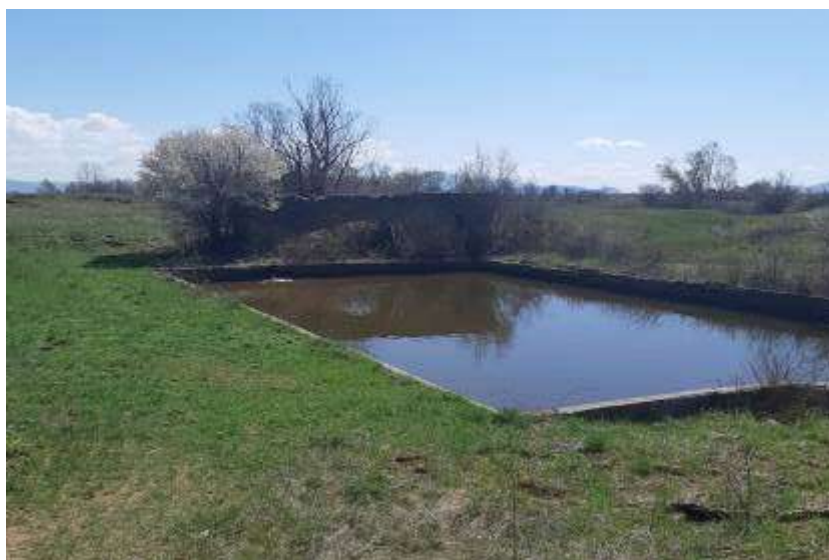
Due to this barrier and what it represents in space endemic fish species that were described earlier in the report have an obstacle to migrate underground to survive during hard conditions such as drought and lack of water in their natural habitat.

Figure 10. Barrier in the form of cattle pool near Čaića ponor¹⁴
