NGO “DINARICA” Final Report of Experts on the Project: „Towards the first removal of barriers /dams (on watercourses) in Bosnia and Herzegovina: Livanjsko polje case study“

Mostar, October 2023.

Title of the Project: “Towards the first removal of barriers /dams (on watercourses) in Bosnia and Herzegovina: Livanjsko polje case study”.

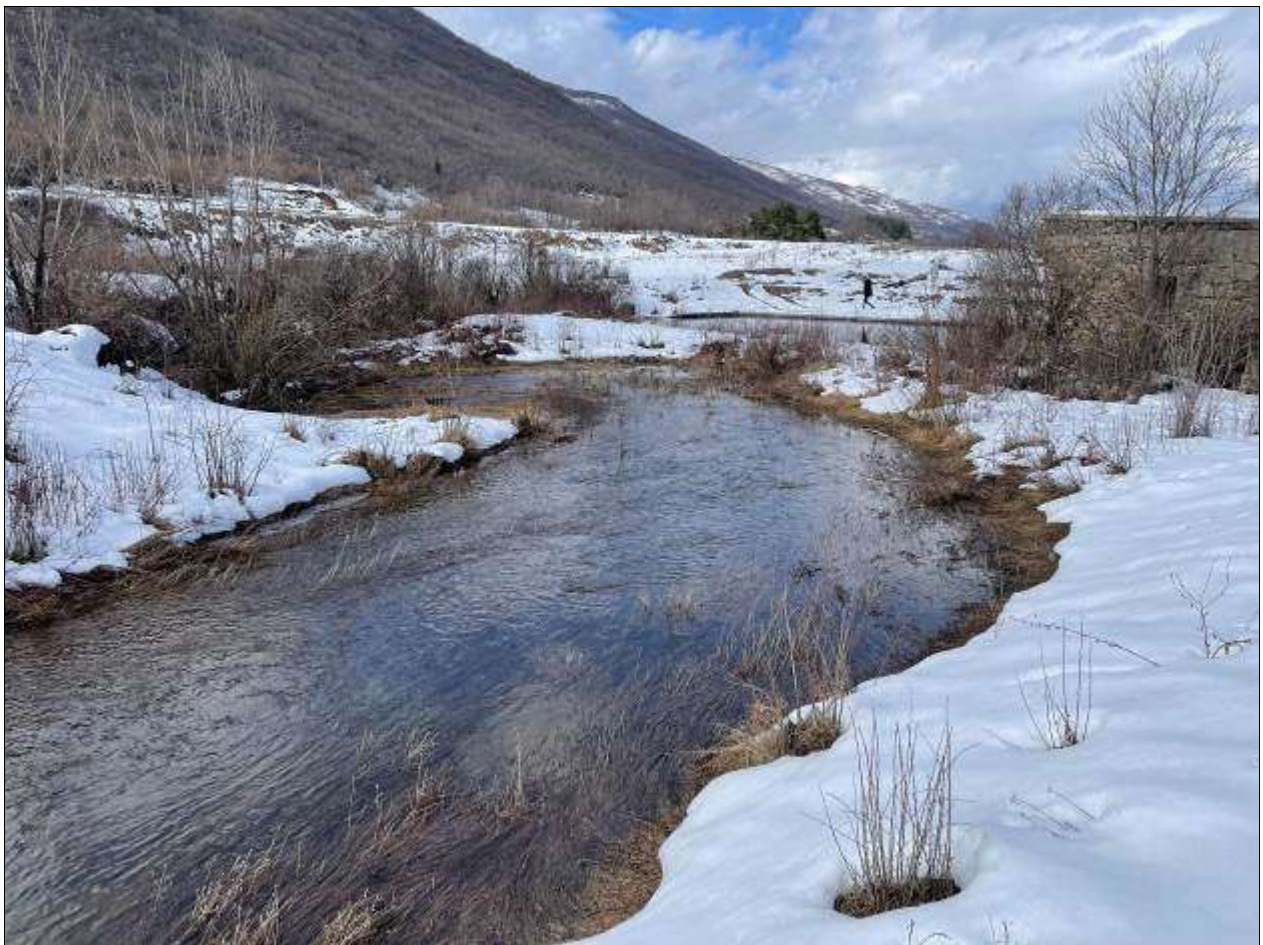
Picture 1. River plovuća upstream of Čajić ponor(sinkhole) (February 2023.)

In the bed of the Plovuća River, two structures have been identified, recognized as two barriers that do not serve any hydraulic function and are planned for demolition.

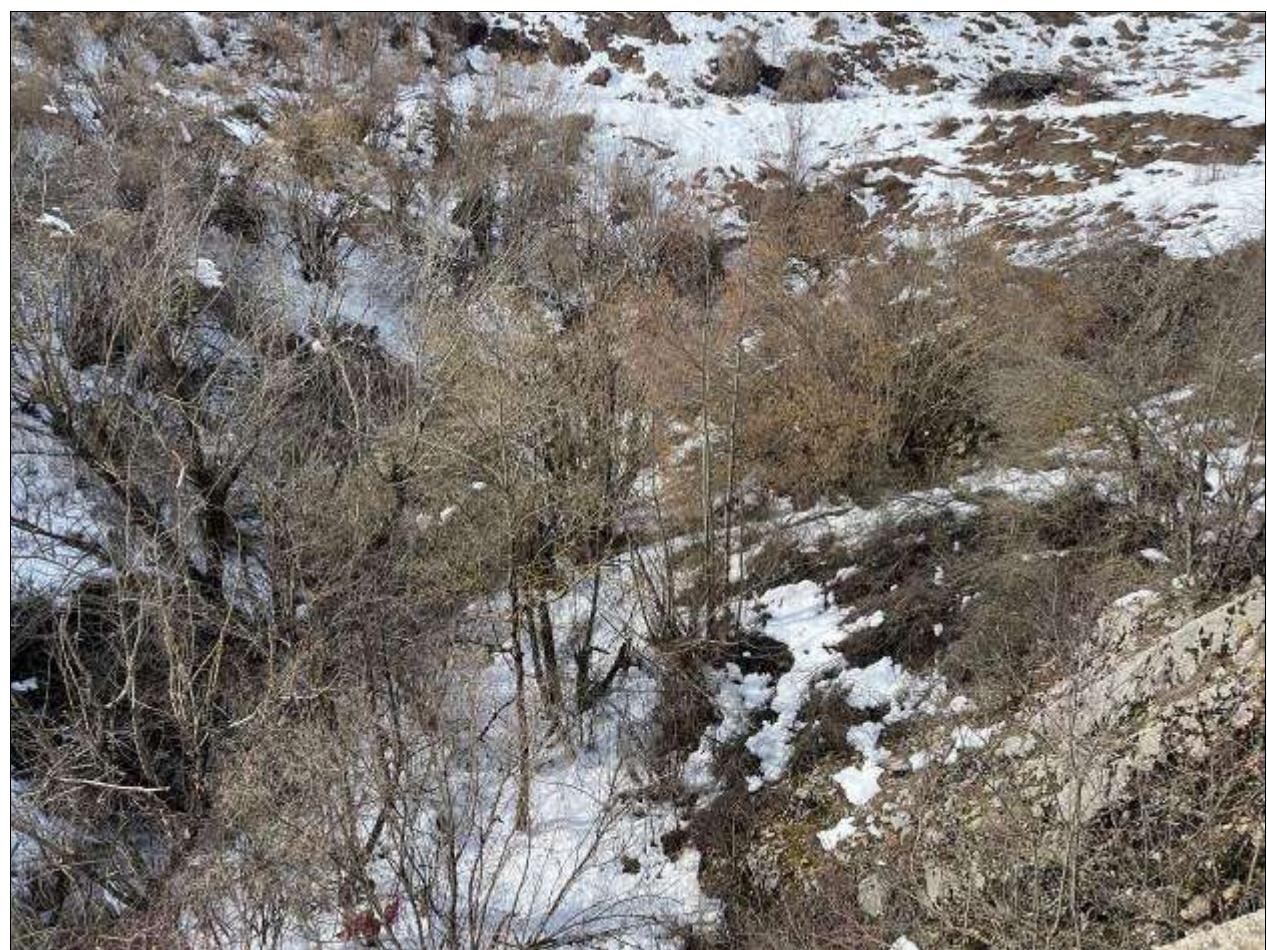
The structure of the old mill (Duića mill) in recent times does not serve any economic or residential function. Considering the complete devastation of the structure, it can be stated that it does not serve any tourist function. The structure was made of concrete during the early 1960s and is located directly adjacent to the stream bed to harness the power of running water for milling wheat and corn. The structure is approximately square-shaped, with a total perimeter of about 105 meters, indicating that each side is approximately 10

Picture 2. Ponor zone of Plovuća river (Veliki ponor or Čajić ponor).

The average height of the walls is approximately 3 meters, with the wall height along the stream being around 8 meters. The average wall thickness is about 50 cm. The structure comprises two main rooms separated by a partition wall, along with a small entrance area providing access to these rooms. There are no remnants of installations or equipment from the former mill, further indicating that the structure has been completely abandoned. An important aspect defining the operational capabilities of the mill is related to hydrological seasons. It can be noted that the structure could not operate during the summer period when the Plovuća River (like most surface watercourses in Livanjsko Polje) completely dries up. Consequently, the structure could only function during the colder (winter) period of the year when this part of Bosnia and Herzegovina experiences the main hydrological peak season

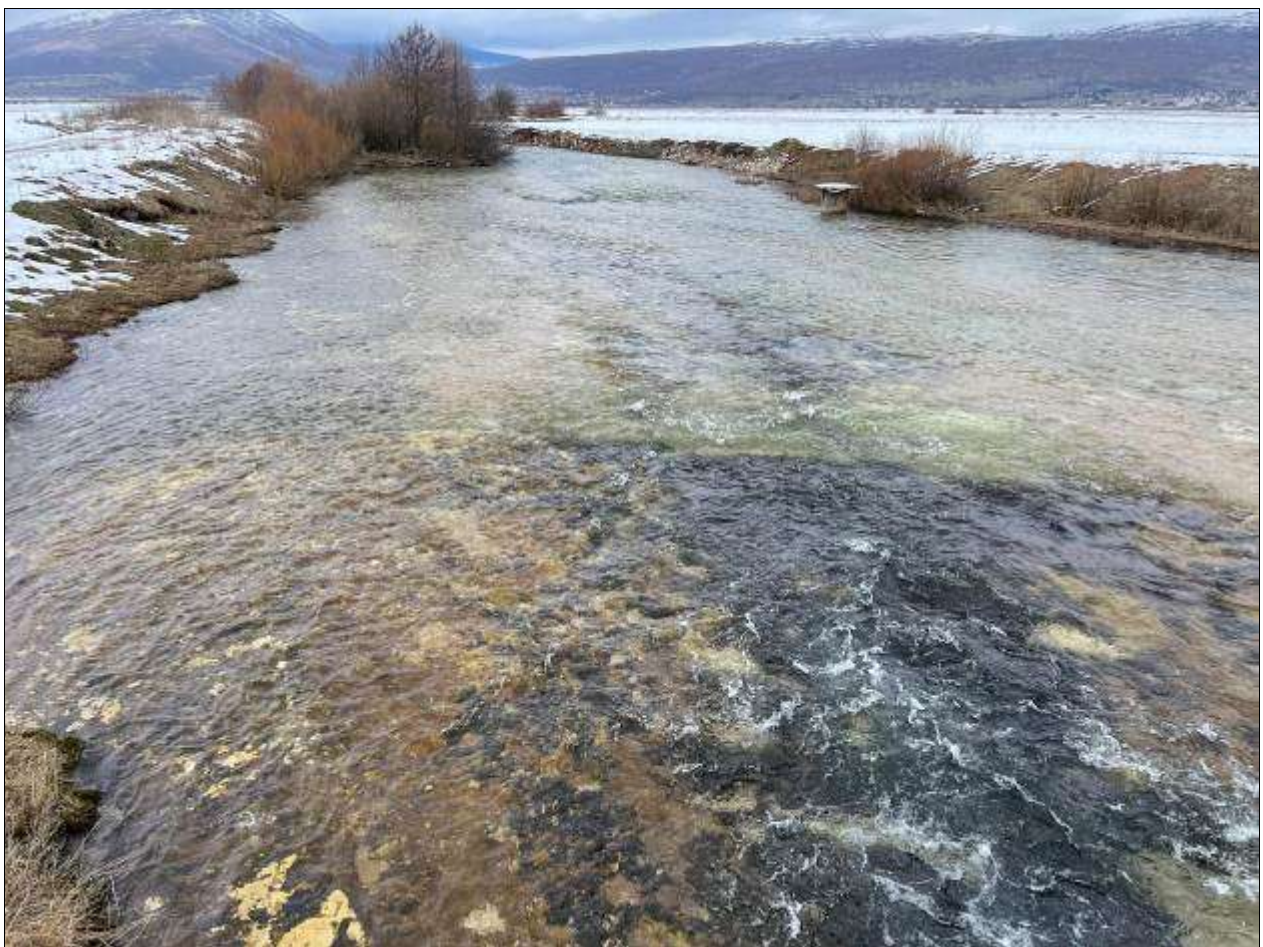
Picture 6. Flow of the Sturba River, immediately downstream from the barrier for removal.

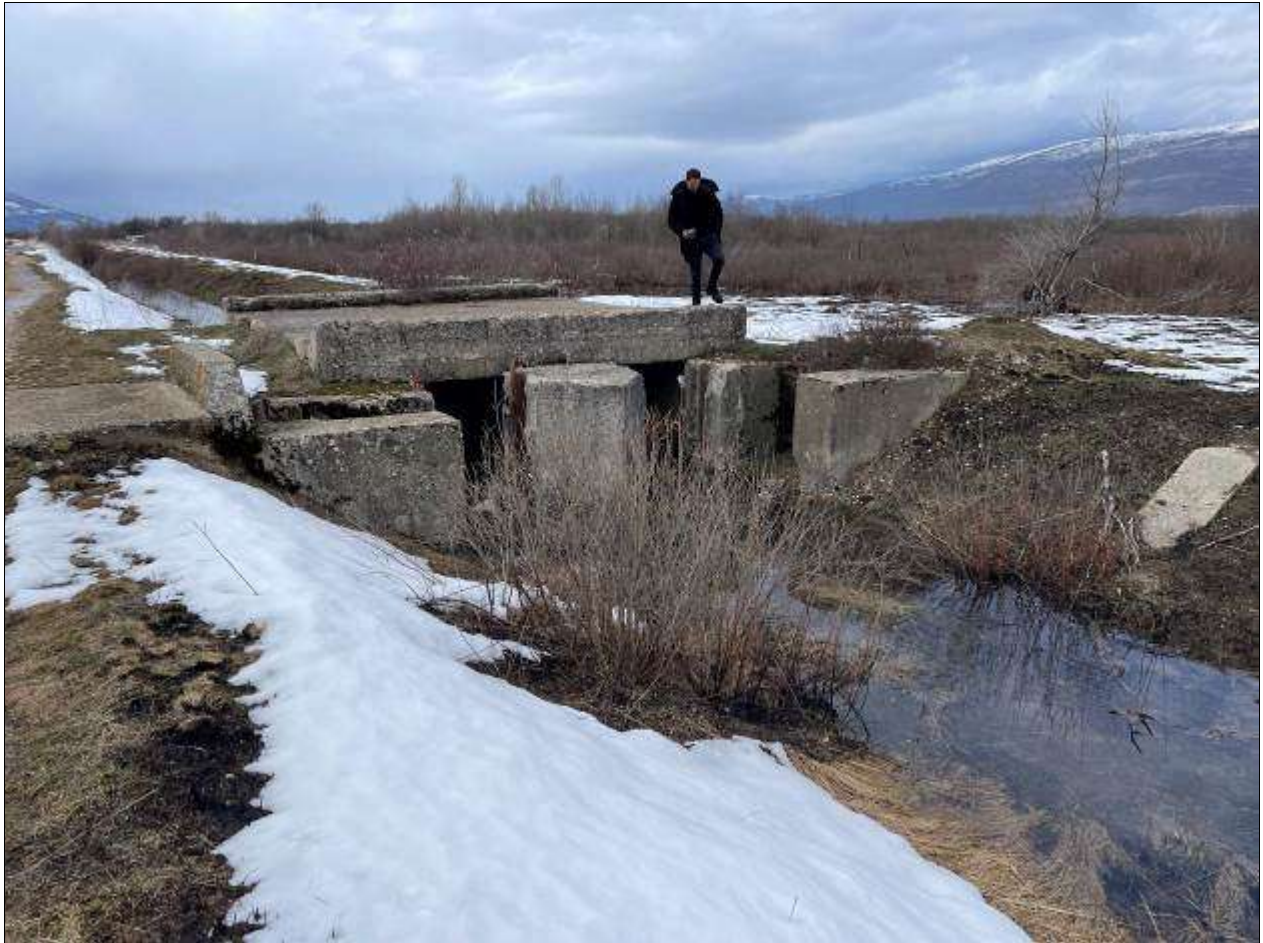
Slika 8. Segments of the drainage channel where small bridges with weirs are constructed.

Considering that the supporting elements of the weir are installed in the channel bed, they represent an obstacle that also needs to be removed. Although constituting a single construction unit, the barrier consists of two separate structures: 1. a concrete weir for water regulation 2. a dam for forming a reservoir.

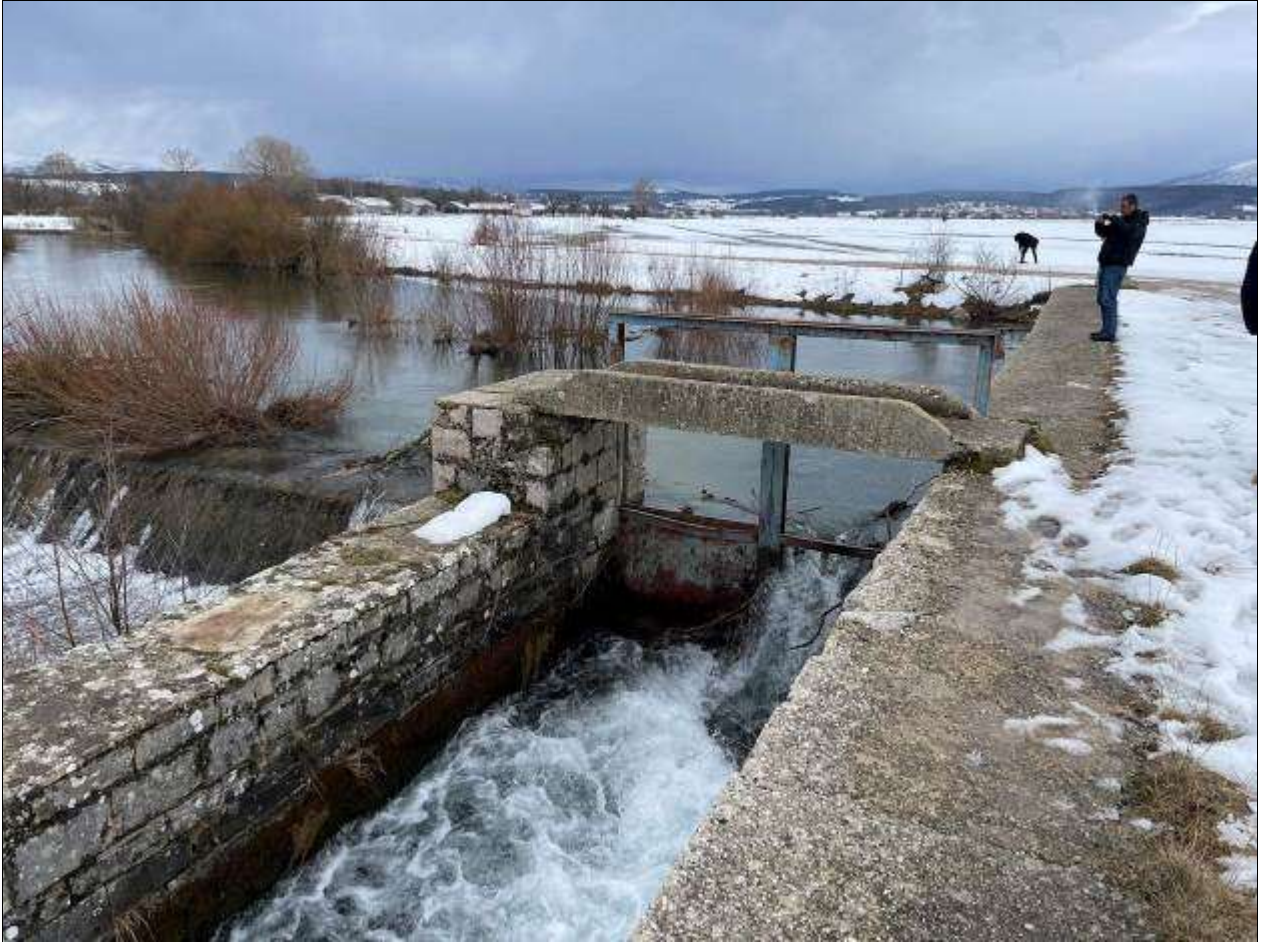
This weir is built in the left part of the channel, with a length of approximately 6 meters. The weir comprises a metal frame about 50 centimeters thick, with a flap used to raise or lower, thereby controlling the size of the opening for water flow. The weir serves the function of regulating the water flow of the Sturba River into the left artificial channel or redirecting a part of its water into a canal for hydro-improvement activities (see map 9.)

Picture 9. The weir along the left bank of the riverbed no longer serves any hydrological function and therefore requires removal

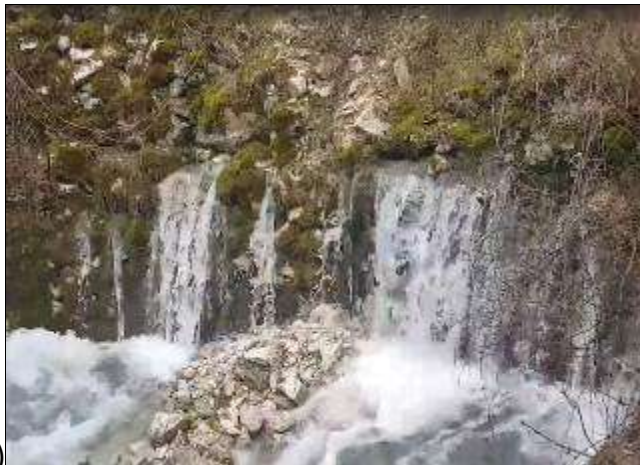
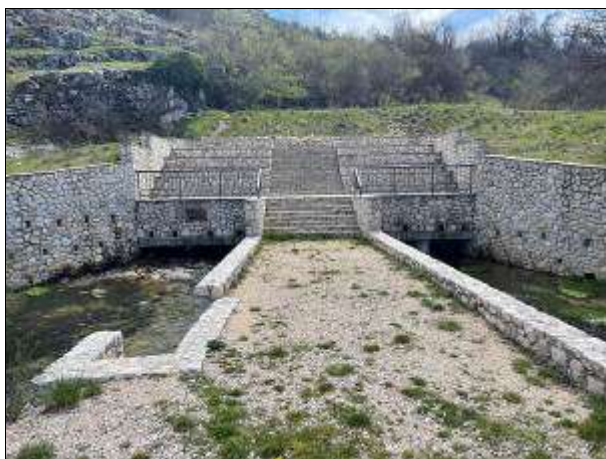
Picture 11. Izvor rijeke Sturbe: a) prije uređenja, i b) nakon uređenja

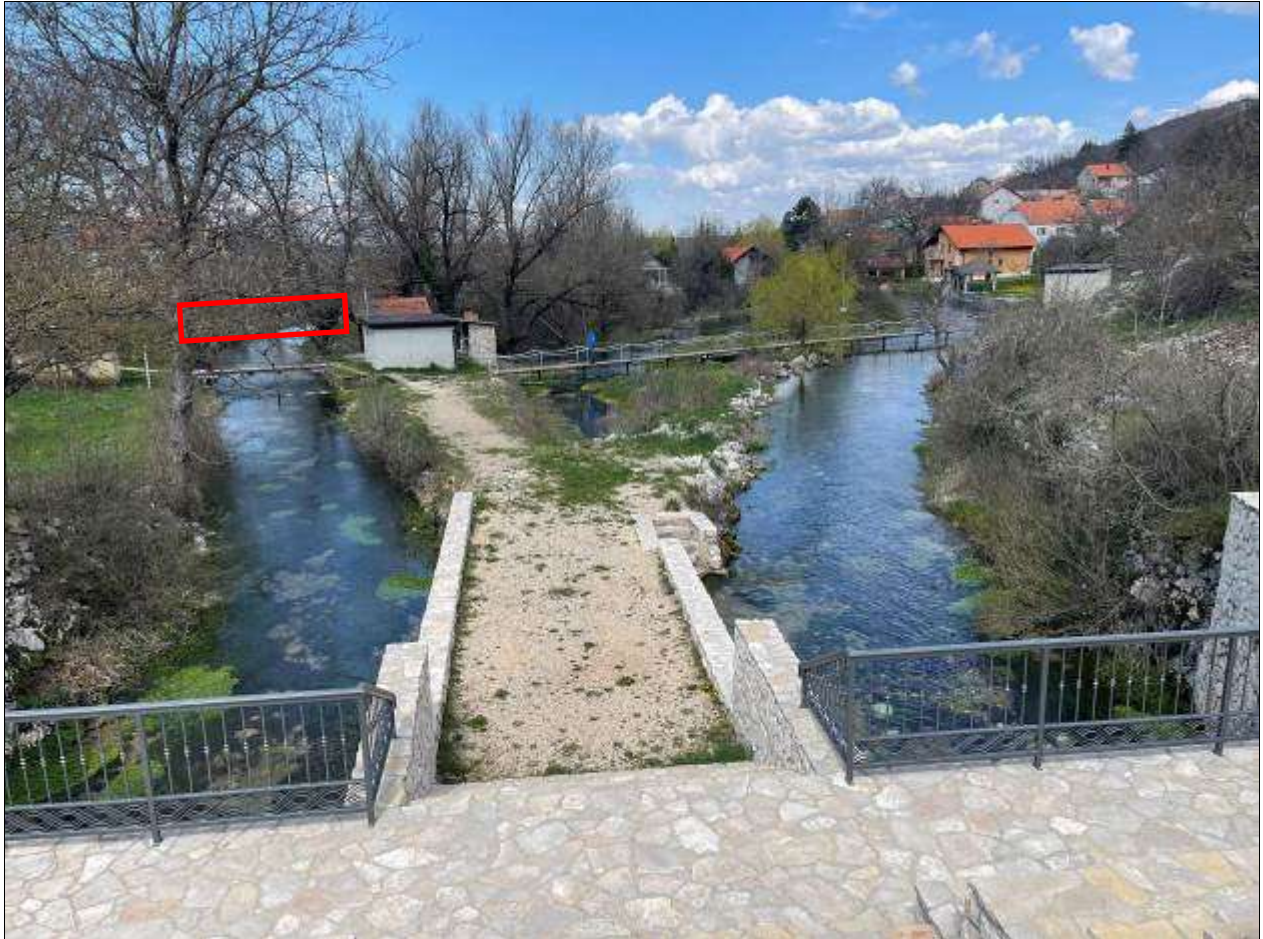
Barrier for removal is constructed in the left branch of the source stream, approximately 36 meters away from the concrete wall of the spring (see Figure 12.). The barrier consists of a

concrete beam about 50 centimeters wide and approximately 1.5 meters high. The width of the stream and therefore the barrier is around 5 meters. The barrier remains underwater throughout the entire season of hydrological maximum (the entire colder period of the year, from November to May), while during the summer, when water levels are at a minimum, the upper part of it is above the water surface. In such situations, a small accumulation is formed, which, due to high water temperatures, becomes eutrophic, producing unpleasant odors emitted into the immediate surroundings. Additionally, the increased amount of accumulated heat from the reservoir affects the rise in water temperature both upstream and downstream, further contributing to the modification of the general ecological conditions in this part of the Sturba River."

The barrier is made of concrete with foundations buried about 1 meter deep into the riverbed, while the remaining part, around 0.5 meters, is above the streambed.

Picture 13. Location of the barrier in the left branch of the Sturba River

Considering the above, the expert research project team has proposed the necessity of removing the mentioned barrier. Its removal should be executed using construction machinery, specifically excavators. Construction work to remove it should be carried out during the summer months, during the hydrological minimum season.

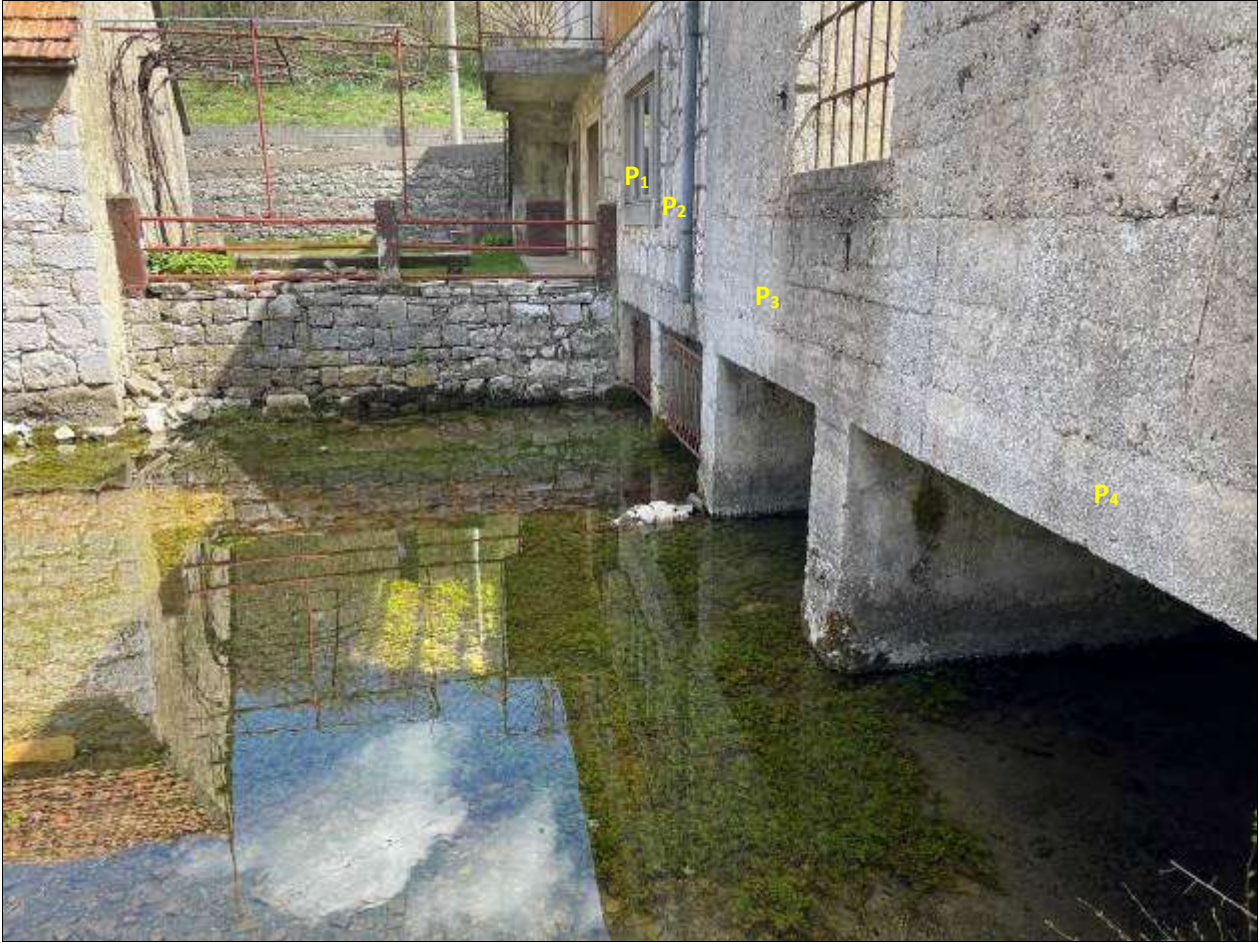
Picture 18. The front part of the space on the load-bearing walls of residential building 2 and auxiliary building 1 where the removal barriers are constructed.

The barriers 1 and 2 have installed metal grilles, likely intended to prevent access to the interior space, that is, the spaces between the load-bearing walls of the buildings. The other two openings do not have any additional built-in construction elements.

The removal of the mentioned barriers involves mechanized construction work to demolish the rear sections of the load-bearing walls. Their removal would create space for unobstructed water flow in the right branch of the Sturba River. A specific aspect of the activities in removing the barriers includes assessing the structural integrity of residential building 2 and auxiliary building 1, necessary to evaluate the effects resulting from the

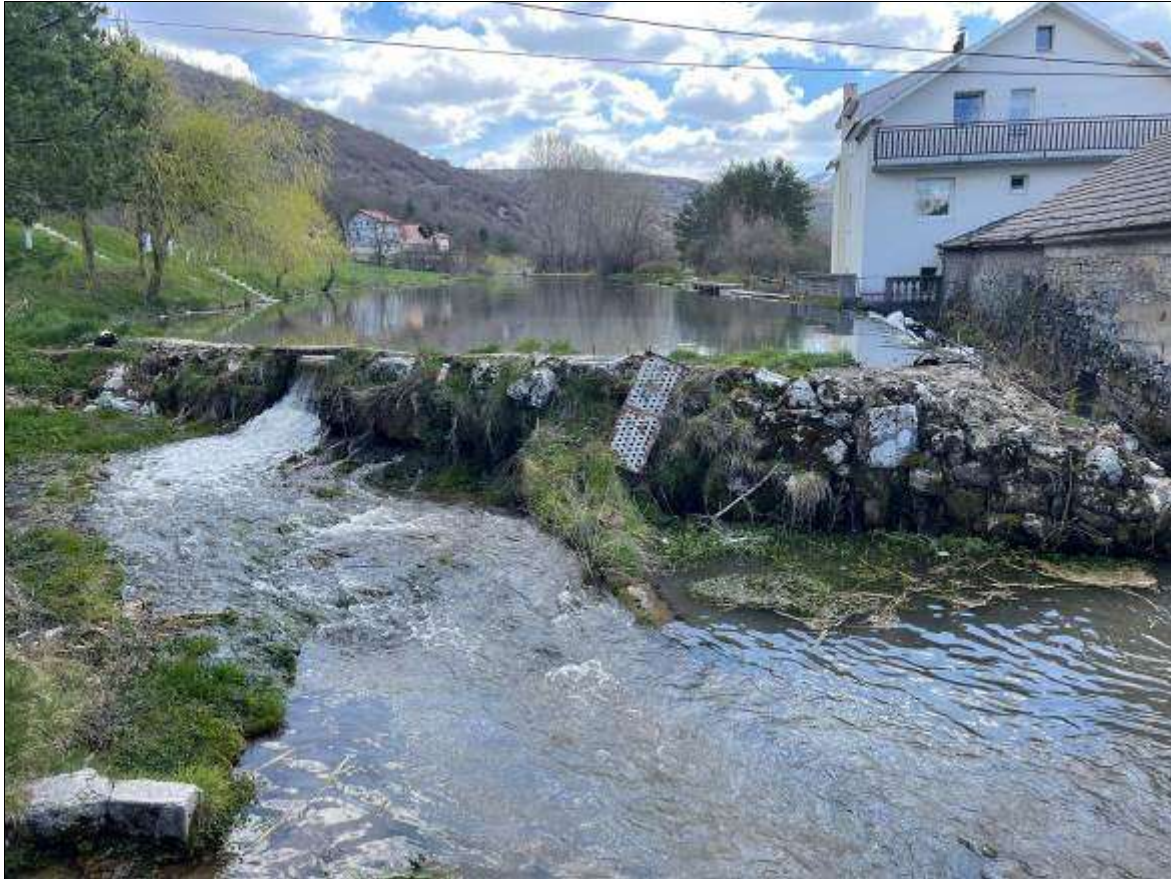
Picture 21. Spatial position and characteristics of the transverse and longitudinal barrier on the Sturba River in the Kaselj settlement area.

The barrier in this part of the Sturba River consists of two sections. The first section comprises a transverse barrier formed across the Sturba's course, while the second part is established along the left side of the riverbed. The transverse part of the barrier is, in fact, a smaller concrete-stone dam about 3 meters in height and approximately 15 meters in length. The base width of the barrier ranges from 2.0 to 2.5 meters, while its upper part is around 1 meter wide. At the central part of the transverse barrier, near its top, there is an opening that serves as an outlet for excess water accumulated during periods of high water levels in the dammed area (see figure 23). The longitudinal section of the barrier is formed along the left side of the riverbed and extends for approximately 42 meters. This part of the barrier is also constructed using concrete and masonry stones, with an average height between 1.5 to 2.0 meters (see figure 24).

By removing the mentioned barrier, the Sturba River would be restored to its natural state, reinstating the hydrological regime of the river. Additionally, the removal of the barrier would enable unobstructed migration for ichthyofauna and other native species inhabiting the Sturba River. The restoration to its natural state would also revive its significant role as a habitat for migratory bird species during the spring and autumn migration seasons from Northern and Central Europe to North Africa and vice versa.

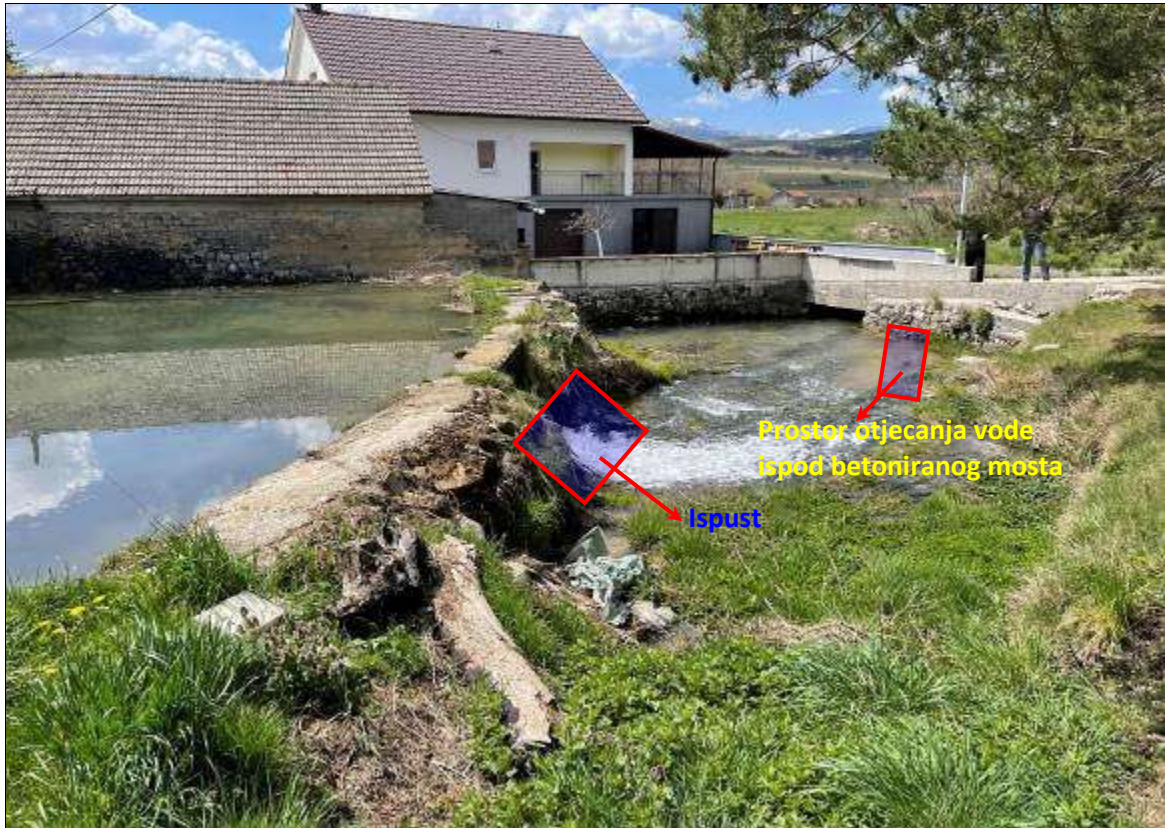
Picture 22. Spatial position of the transverse barrier with the position of the overflow opening for the discharge of excess water accumulated in the dammed area.

The total surface area of both barriers in the upper part is around 120 m², with a minimum volume of the above-water part of the barrier measuring approximately 250 m³. The total amount of material used in constructing the barrier includes the material incorporated into its foundations, thereby increasing the mentioned volume of embedded material by about 1/3.

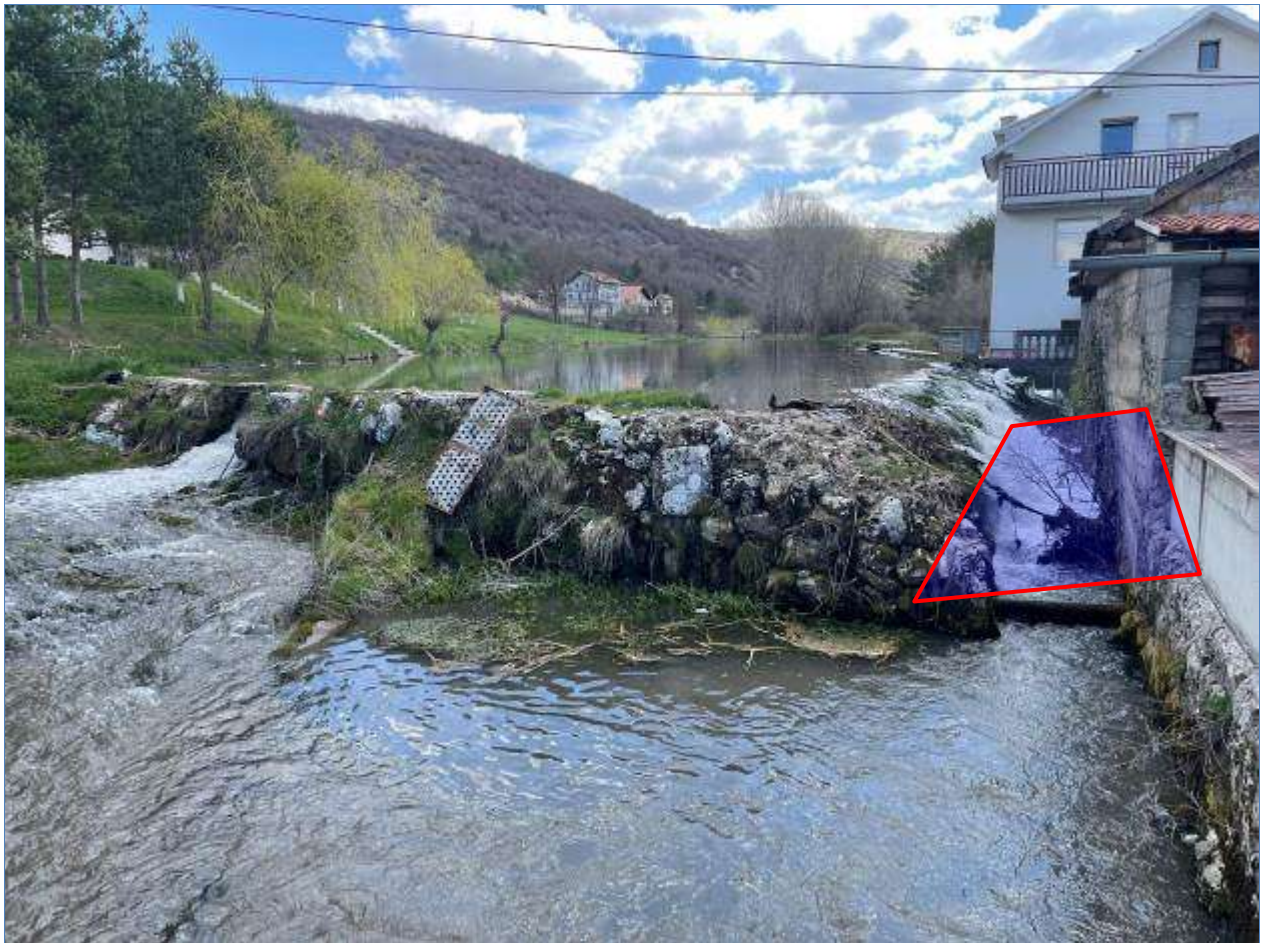
adjacent structures. Utilizing the increased energy from a drop of about 1.5 meters, the water is used to power the mill blades installed in the structures along the channel.

Figure 24. The spatial position of the channel used to direct water onto the mill blades..

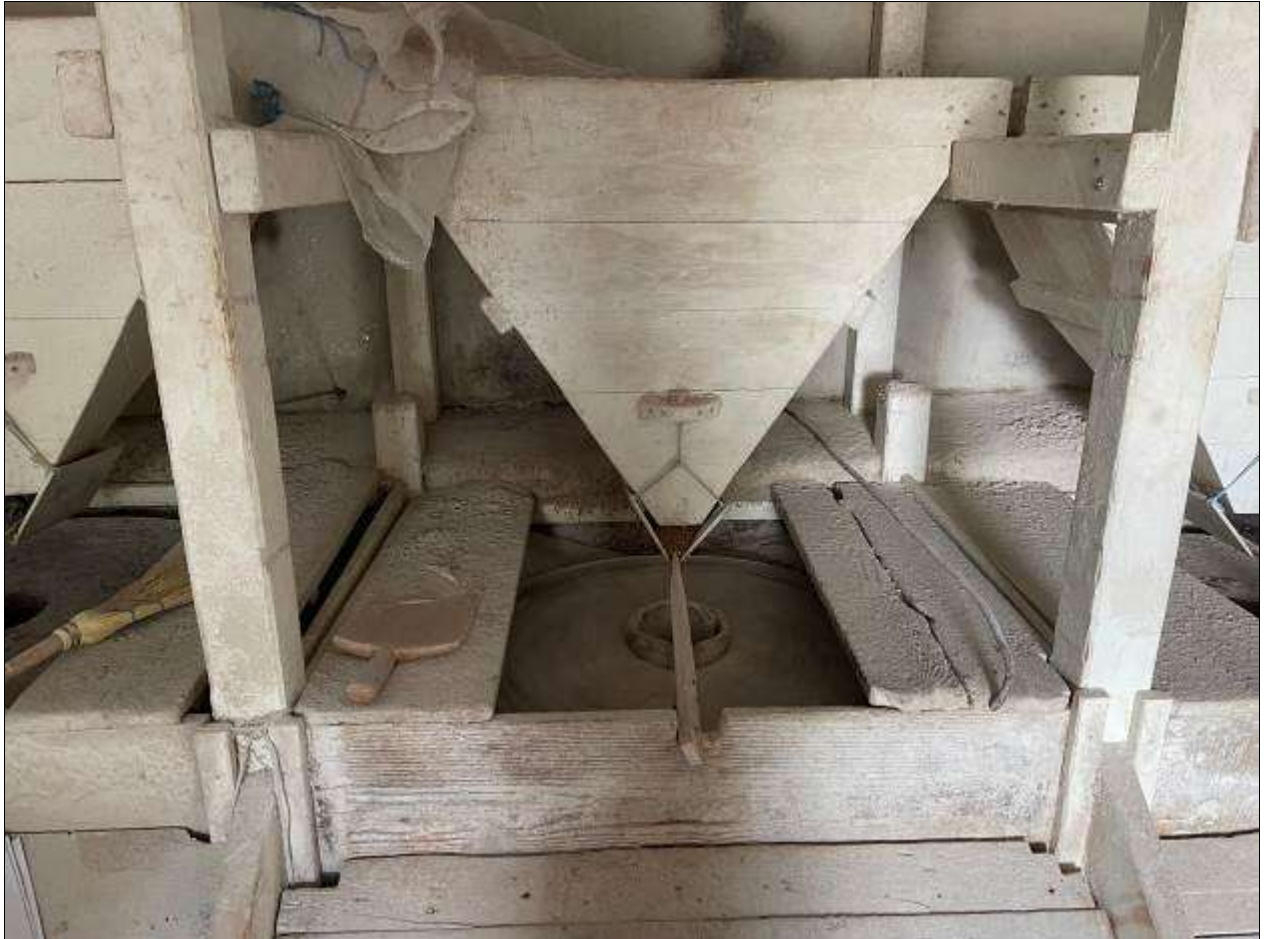
Field inspections have confirmed that several mills are still active, processing grains (see figure 25.). All these structures are built directly adjacent to the riverbed of the Sturba River, making this segment almost entirely human-altered. Including the constructed concrete vehicular bridge, the riverbed of the Sturba River has been developed and covered over a length of approximately 28 meters. It is important to note that these active mills are often promoted as part of the cultural and historical heritage of the Livanjsko Polje and are

frequently visited by tourists. Most of these structures are privately owned, which further complicates the proposal for the removal of the mentioned barrier.

Figure 25. The grain mills used for processing are still active today, powered by the channeled water energy.

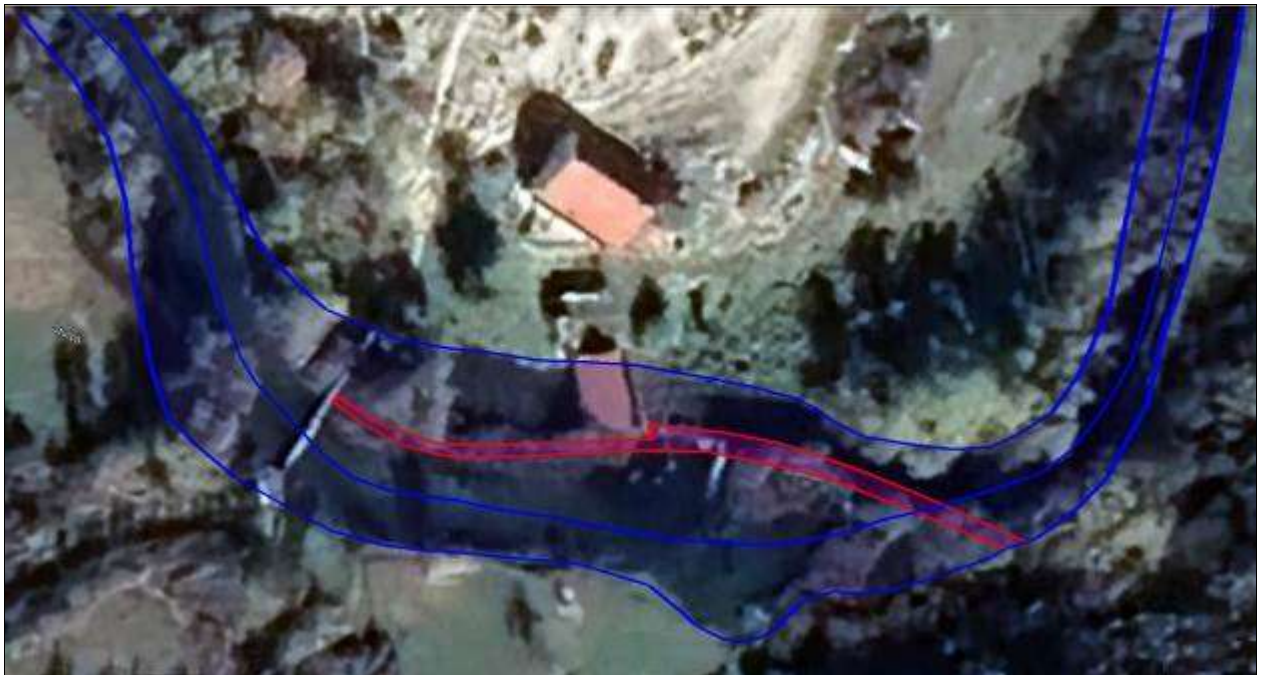
The barrier on the Sturba River at the Kelavin Mlin site is formed along the entire transverse profile of the riverbed, diagonally in relation to the river's main flow. The barrier consists of several segments covering a very long strip, starting from the pedestrian bridge along the right bank of the stream to the left bank (see Figure 26). Most of the barrier is constructed by cementing pebbles and larger stone blocks. Vegetation communities of black willow and black ash have subsequently populated the barrier, forming an additional natural obstacle. The total length of the barrier is over 91 meters. Coordinates of the barrier centroid: $\phi = 43^{\circ}46'52.60''N$; $\lambda = 16^{\circ}58'36.89''E$; H = 732 m above sea level. Dimensions of the dam: Length 50 meters, height 2 meters (including the dam's foundations), with an average width of about 1.0 meter (approximately 1.5 meters at the dam's base). The barrier is divided into two separate structures (see Figure 27). The first barrier predominantly diagonally intersects the Sturba's course from the left bank to the mill structure (see Figure 28). The total length of the first barrier is approximately 50 meters.

Slika 26. Spatial position of the barrier on the Sturba River at the Kelavin Mlin site

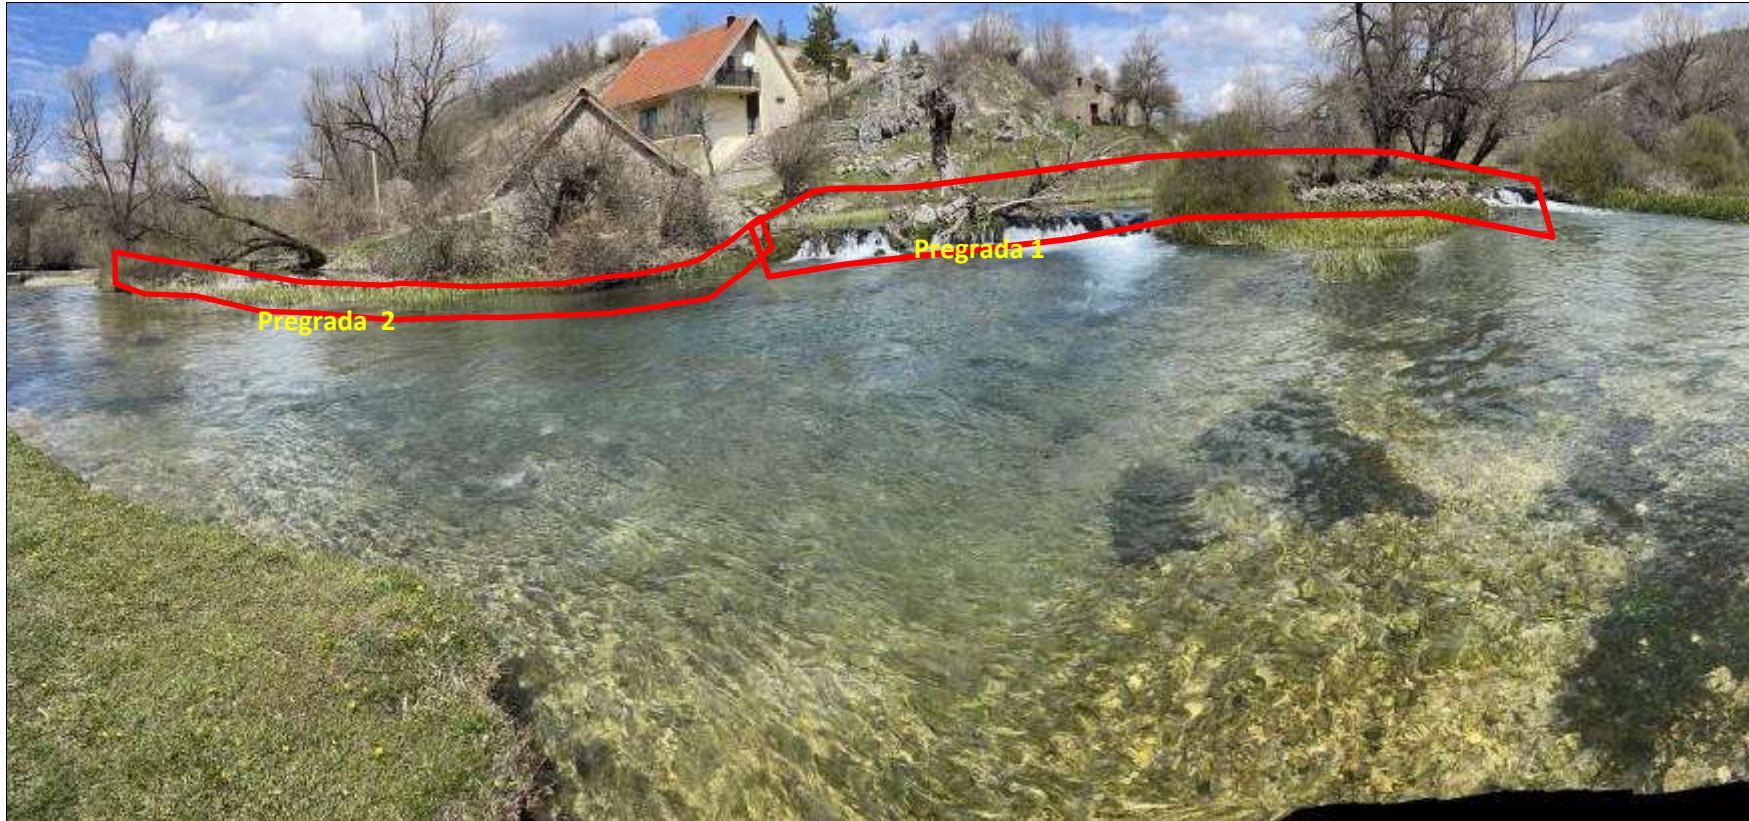
Figure 27. Spatial position of barriers for removal on the Sturba River in the Kelavin Mlin area

In the central and left part of the first barrier, outlets have been built through which the excess water from the accumulation spills into the downstream section of the Sturba streambed. The second barrier is constructed in the right section of the riverbed, encompassing the stretch from Kelavin's mill to the pedestrian bridge. With this barrier, the inflow channel is separated from the Sturba stream, from Kelavin's mill to the bridge (where the channel reconnects to the river - see Figure 30). The length of the second barrier exceeds 40 meters. It is also constructed from larger stones with cement binding, with an above-water part height of about 1.0 meter. The foundation depth of the second barrier reaches up to 1.0 meter while its width extends up to 1.5 meters.

During field research, it was noted that the mills do not have a consistent economic function, providing the necessary conditions for the comprehensive removal of the built obstruction, which has dammed the Sturba River bed and significantly altered the natural hydrological regime in this section of the watercourse. This area is managed by a fishing association that uses this part of the river as a fishing ground.

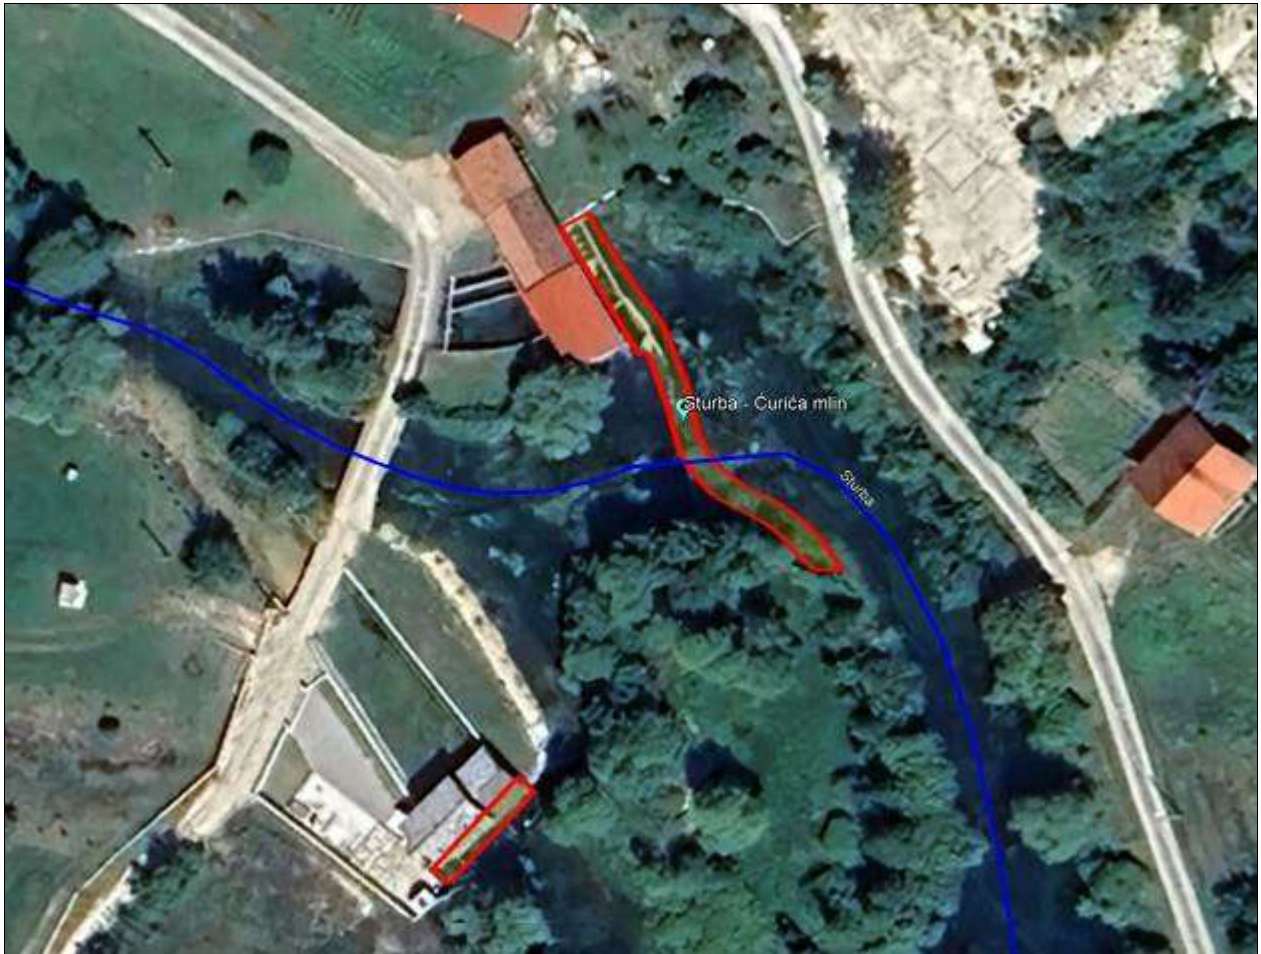
Map 34. The spatial position of the barriers on the River Sturba in the Čurića mill area.

The first barrier obstructs the flow of the Sturba River in the widest part of the channel, directing a portion of the water towards the mills constructed at the Čurića mill. The average width of the initial obstructed section of the Sturba River measures over 7 meters and is directed towards three separate openings built at the ground level of the facility. Behind these mill openings, there is a pond specifically designated for the cultivation of consumable fish. To be more precise, the water that passes through the mill openings accumulates in three distinct basins used for the breeding of consumable fish. Based on these highlighted facts, it can be noted that the first barrier provides water for two active commercial functions of this facility.

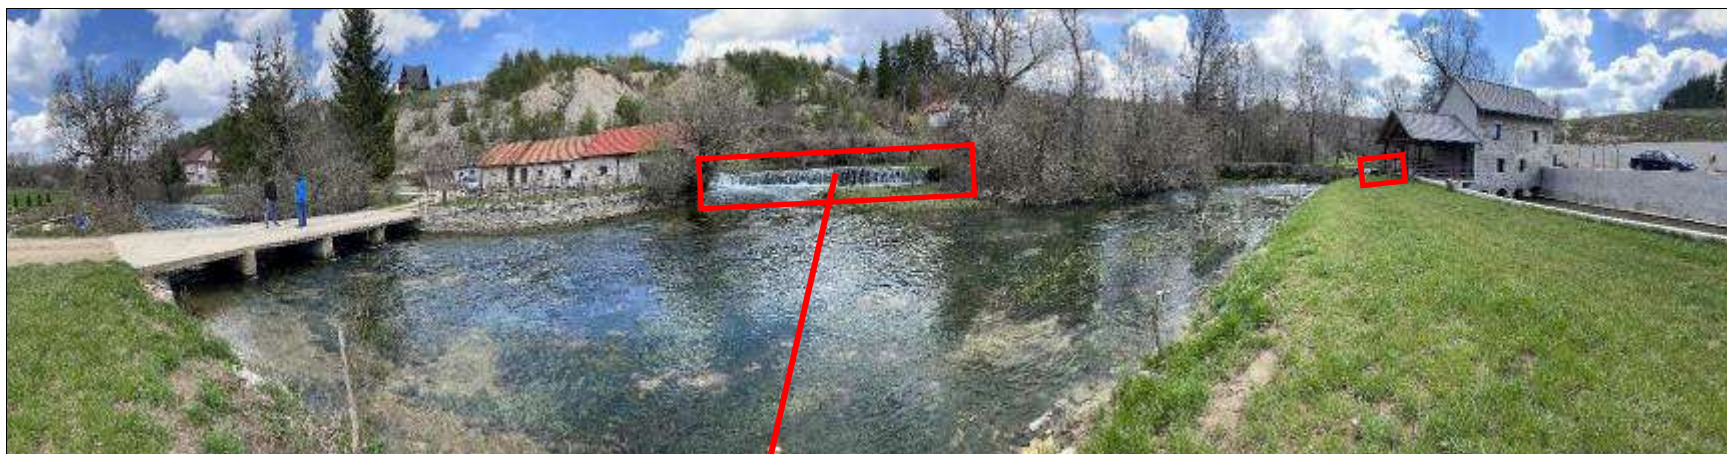
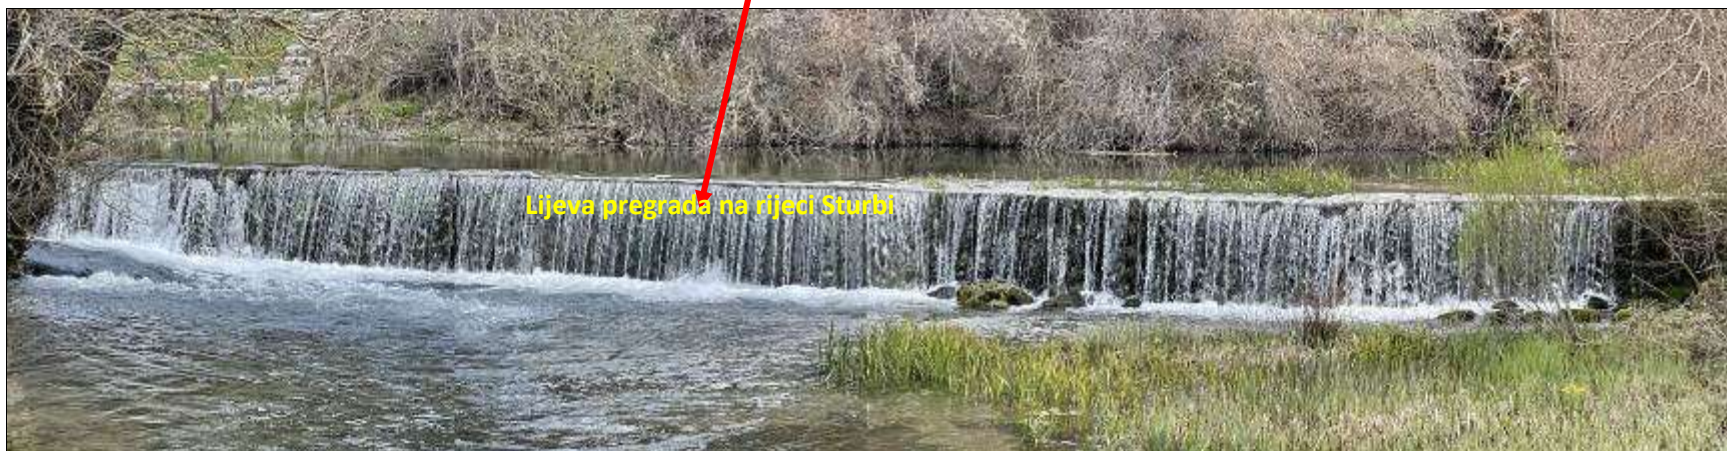
The length of the dam is about 53 meters, its width approximately 2 meters, covering a total area of around 150 square meters of the riverbed. The height of the dam, including its foundation, is about 3 meters, with a base height of around 1.5 meters. The dam is constructed from concrete in combination with stone (see images 34 and 35).

Coordinates for the centroid of the first dam: $\phi = 43^{\circ}47'13.64''N$; $\lambda = 16^{\circ}58'24.83''E$; $H = 730$ m above sea level. The dam obstructs the flow of the Sturba River perpendicular to its main course. The nearby mills, one on the left side and the other on the right, are operational, which likely renders the dam site unsuitable for demolition.

Figure 34. Panoramski view on the barriers.
