NGO “DINARICA” Final Report of Experts on the Project: „Towards the first removal of barriers /dams (on watercourses) in Bosnia and Herzegovina: Livanjsko polje case study“

Mostar, October 2023.

Title of the Project: “Towards the first removal of barriers /dams (on watercourses) in Bosnia and Herzegovina: Livanjsko polje case study”.

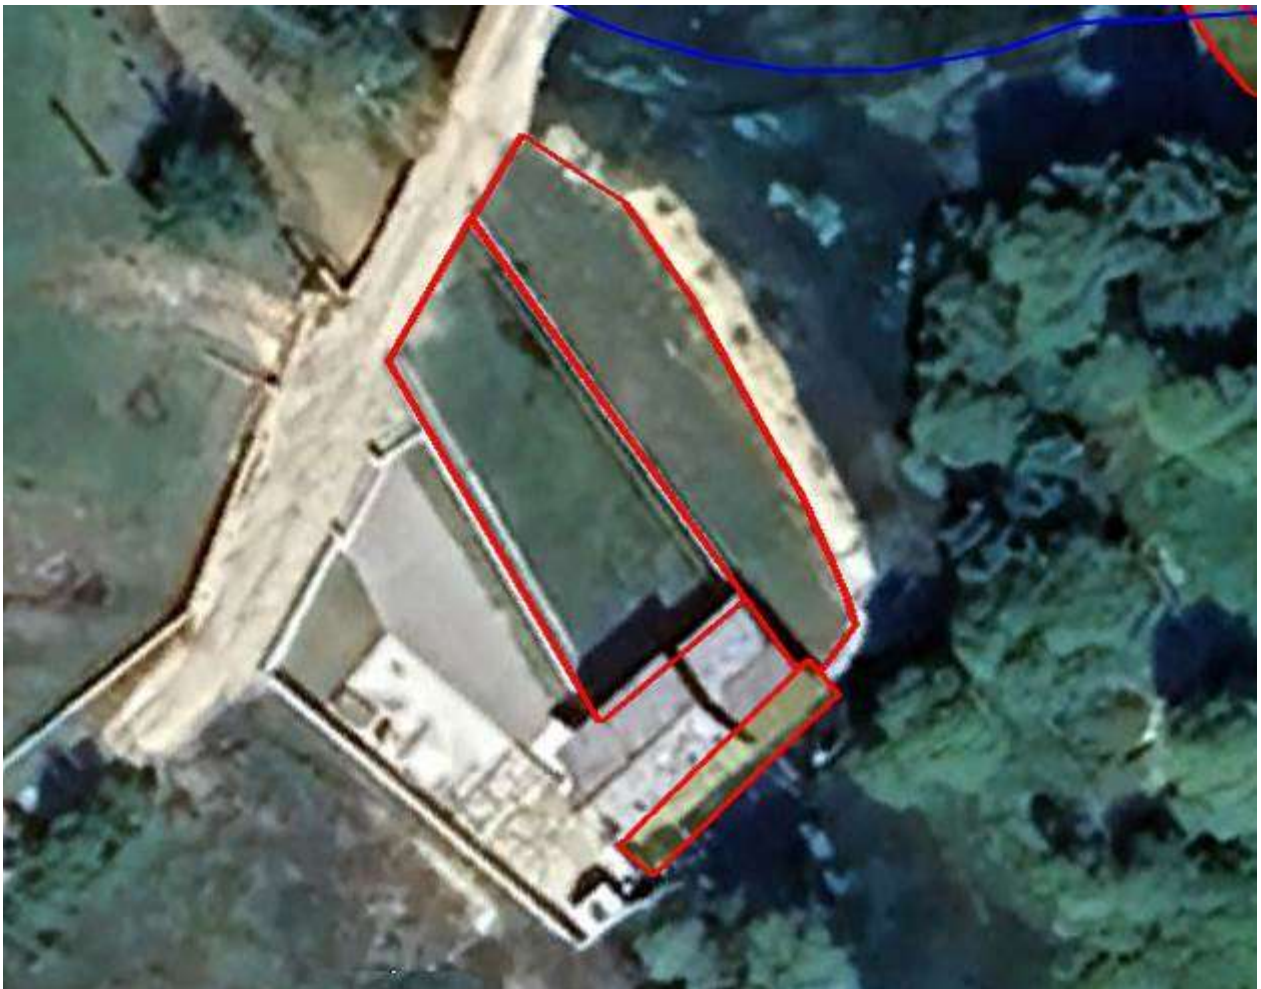
Figure 36.

The second barrier is smaller in size and is situated on the left, secondary branch of the Sturba River. This particular branch has naturally formed along the left side of the river's meandering section. The island's surface measures approximately 1,750 square meters and is covered with hydrophilic vegetation consisting of willows and green alder. The average width of this branch of the Sturba River is around 15 meters, and the water flow is directed towards two separate openings, where two shafts with blades for operating the mills are installed on the ground floor of the structure. The obstructed part of the structure consists of a concrete barrier measuring 13.5 meters x 2.5 meters x 0.8 meters (see figure 36)

Voda se nakon prolaska kroz otvore za mlinice akumulira u betonirani rezervoar u kojem se također nalazi ribogojilište. S obzirom da su objekat mlinice te glavni objekat renovirani može se zaključiti da se radi o objektu koji ima aktivnu ugostiteljsko-turističku funkciju, te se može zaključiti da uklanjanje ove barijere nije prihvatljivo.

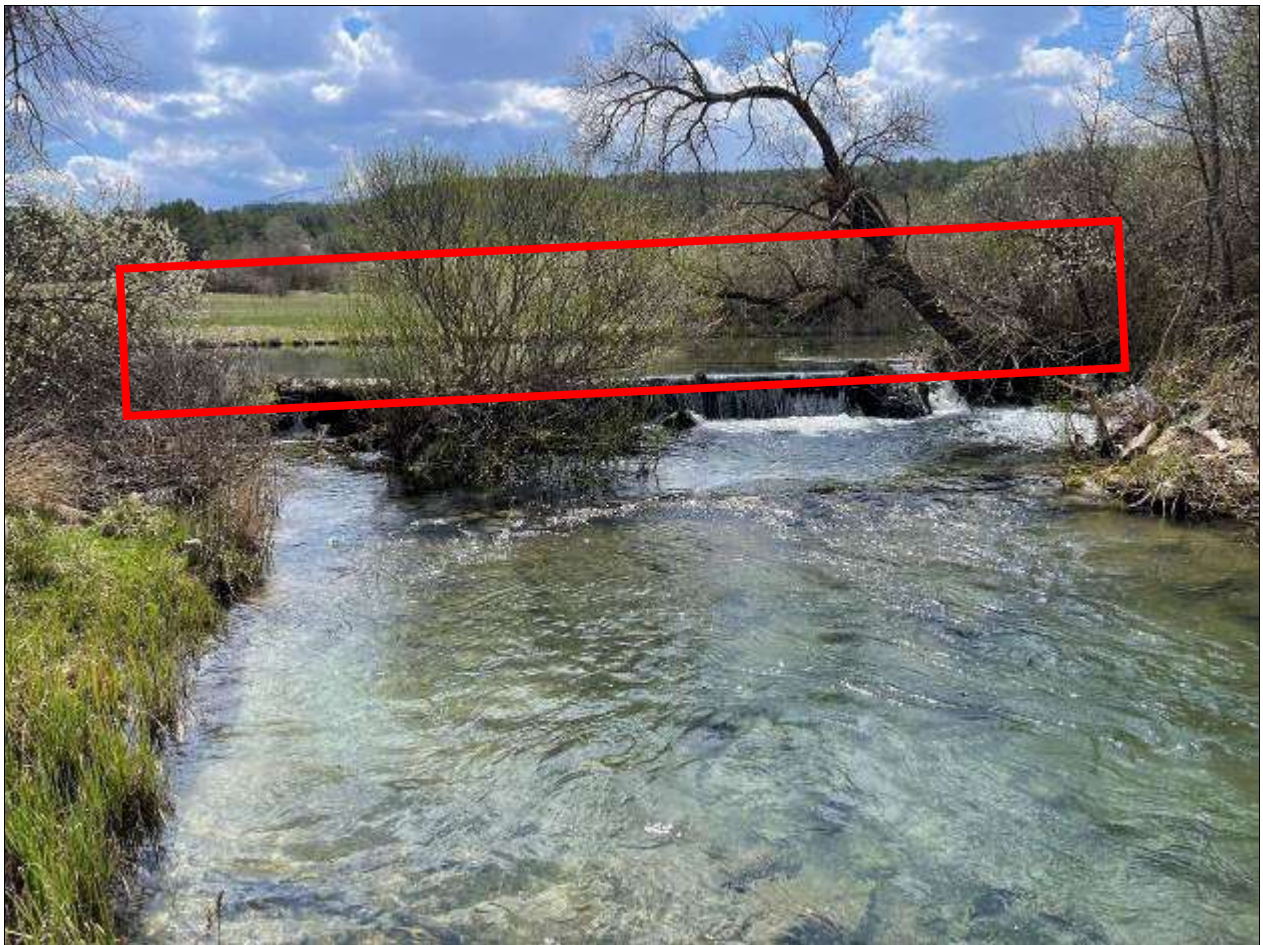
Figur 37..

The barrier at site number 8 on the Sturba River is located in the broader area of the populated place of Donji Golubić. The barrier is situated on the right branch of the Sturba River, which is formed immediately upstream of its location. Specifically, a natural right branch has been formed on the main course of the Sturba River, which extends for about 0.7 km before rejoining the Sturba River. The barrier is positioned at the site where a portion of the water from the Sturba River is redirected into the right branch (see image 37).

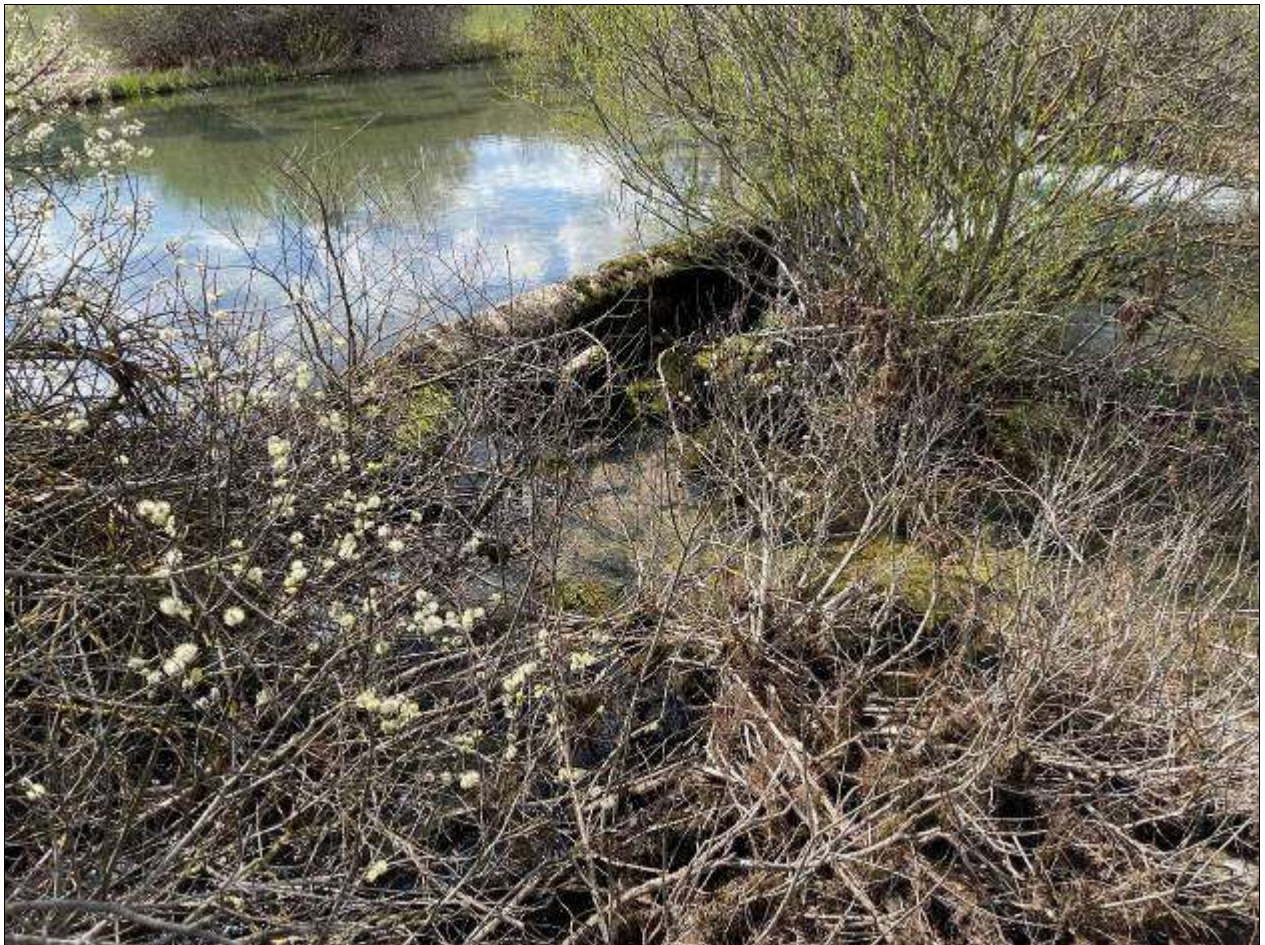
Figure 38.

The mentioned occurrences further enrich the natural values of this area, making it more attractive in terms of the natural diversity of the entire field. The barrier is constructed using a combination of reinforced concrete and stones of varying sizes. The dimensions of the barrier are 13 m x 3 m x 0.8 m. The thickness of the barrier at the base is approximately 1.5 m, while the above-water part ranges from 1.2 m to 0.8 m. Under the influence of microseismic tremors and lateral pressure from the water mass, the barrier is inclined by about 5 degrees in the direction of the water overflow.

The coordinates of the barrier's centroid are: $\phi = 43^{\circ}47'36.21''\text{N}$; $\lambda = 16^{\circ}57'18.38''\text{E}$; $H = 720$ m above sea level. Taking into account that the analyzed barrier does not support specific active commercial functions of downstream objects, its demolition and removal would significantly contribute to the restoration of the primary natural values of this part of the Sturba River valley

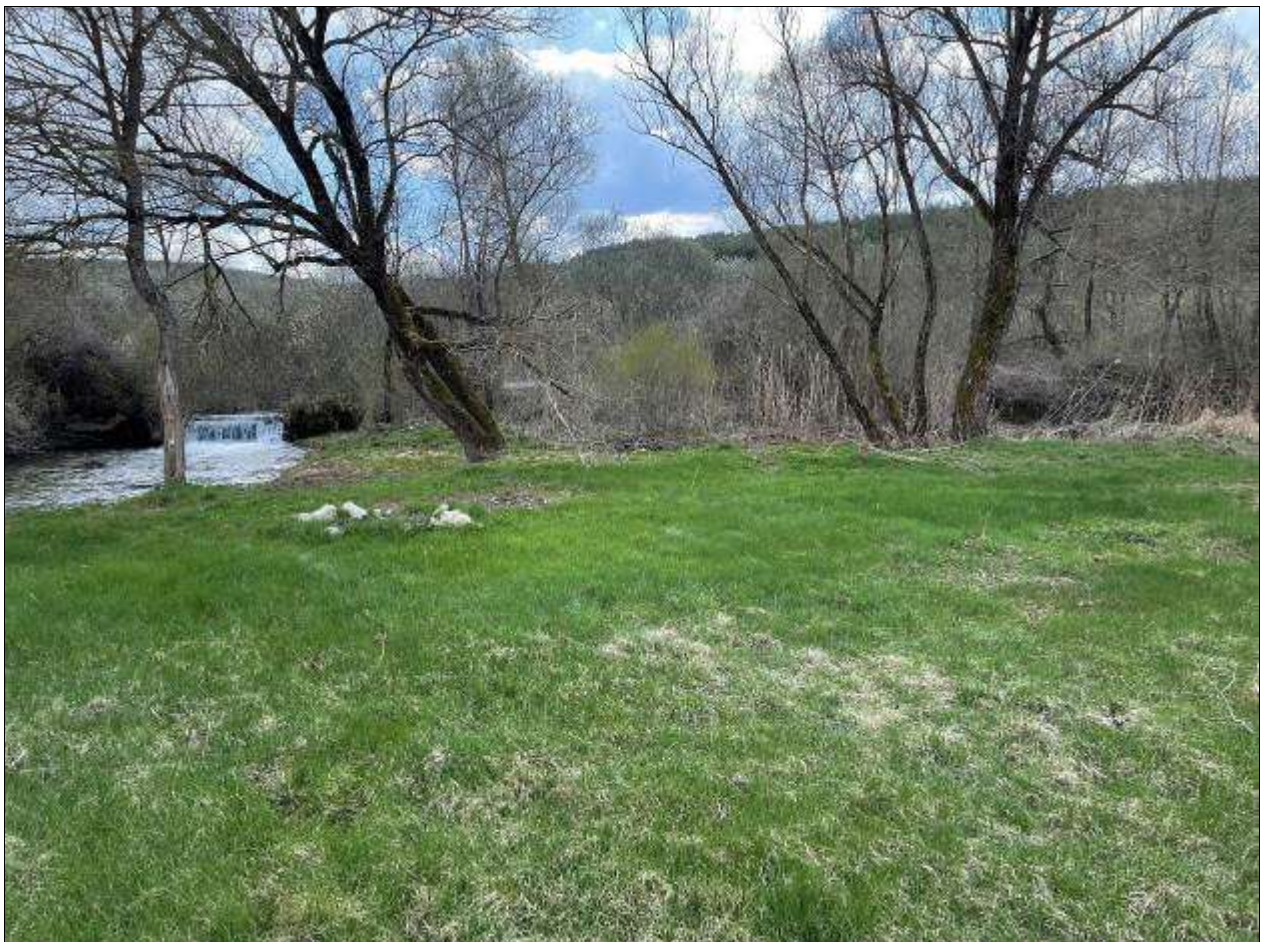
The barrier at the Donji Golubić 2 site is located immediately downstream from the previously mentioned Donji Golubić 1 site. Accordingly, the barrier is situated on the described part of the Sturba River but on the left channel of the stream. Specifically, the barrier is located adjacent to the contact area with the extensive alluvial plain, formed between the two aforementioned channels (see figure 37). The immediate vicinity around the barrier is covered with woody vegetation of willow and alder that developed along the embankment formed along the right bank of the mentioned channel. It consists of earth material obtained by digging out this channel, which was carried out to redirect a part of the Sturba River's water to the mills built in the downstream segment of the channel. The earth embankment is approximately 2 meters high and has an average width of about 1.5 meters. It is assumed that the embankment was constructed during the 1950s

Figure 39. Donji Golubić 2

Considering the mentioned issues, it can be confidently stated that the entire described water protection infrastructure has suffered substantial damage and, as a result, does not fulfill its primary hydraulic function. Consequently, the research team is of the opinion that the entire constructed barrier should be removed to restore this section of the Sturba River to its natural hydrological

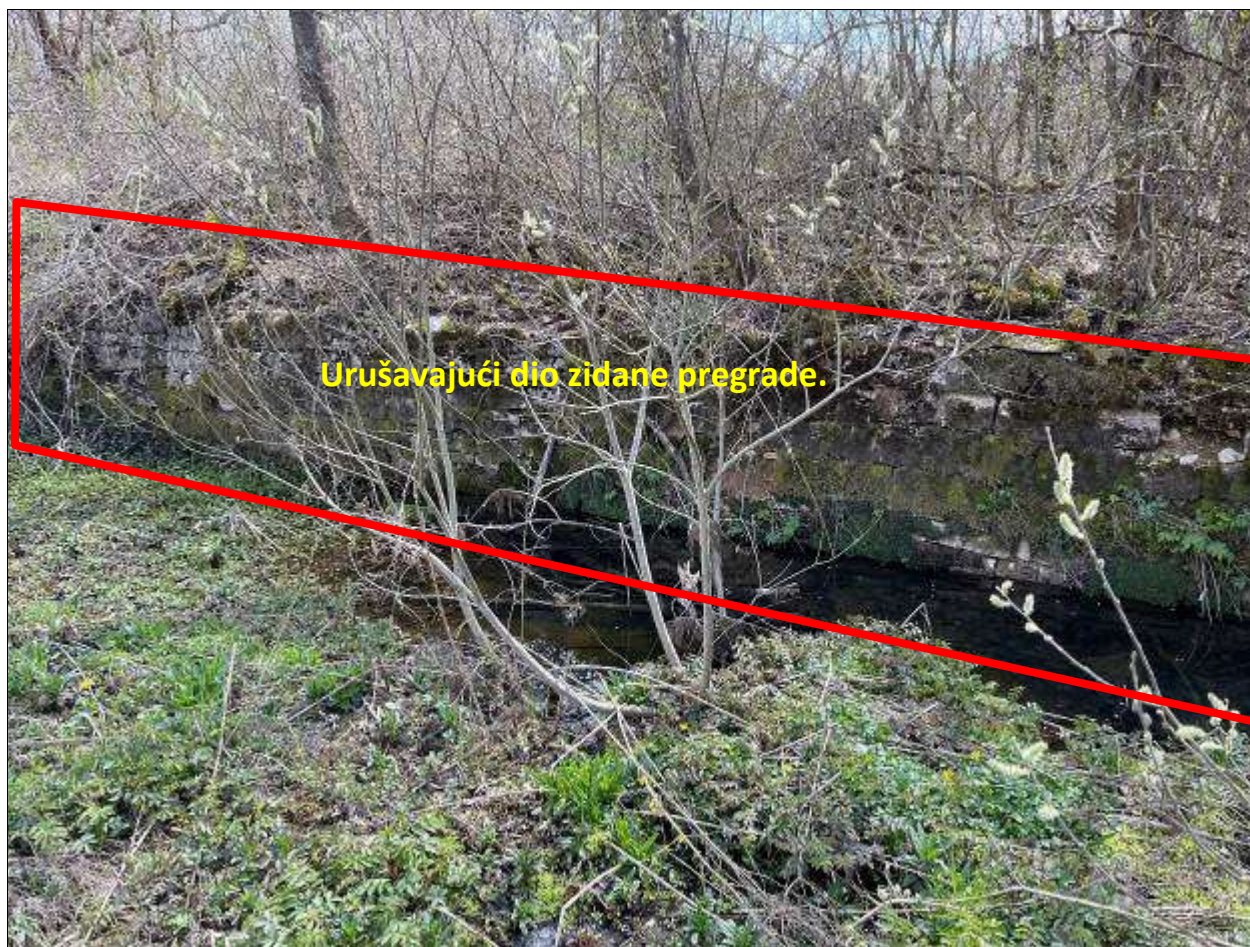
Figure 41. Donji Golubić 2.

Near the initial section of the constructed wall with the embankment, a smaller barrier was built to regulate the water level in this branch of the Sturba River. Due to its intended purpose, the overall height of this barrier is lower, measuring about 1.5 meters. Initially, water release was mechanically controlled, but due to lack of maintenance, this system has been devastated and no longer operational. Consequently, water now overflows over the concrete part of the barrier, specifically its lower base. The length of the barrier is approximately 5.0 meters, with an average thickness of about 1.2 meters at the ground level and around 1.0 meter at the upper (overflow) part (see figure 42). The barrier is constructed from reinforced concrete in combination with stone material. As a result of water pressure and micro-tectonic stresses on the terrain, it has partially cracked and lost its stability.

During fieldwork, it was observed that the earthen embankment and supporting wall were constructed on the left side of the barrier, extending for approximately 5 meters. Similar to the described embankment and supporting wall on the right side, these structures have also been significantly damaged and have largely lost their primary water protection function.

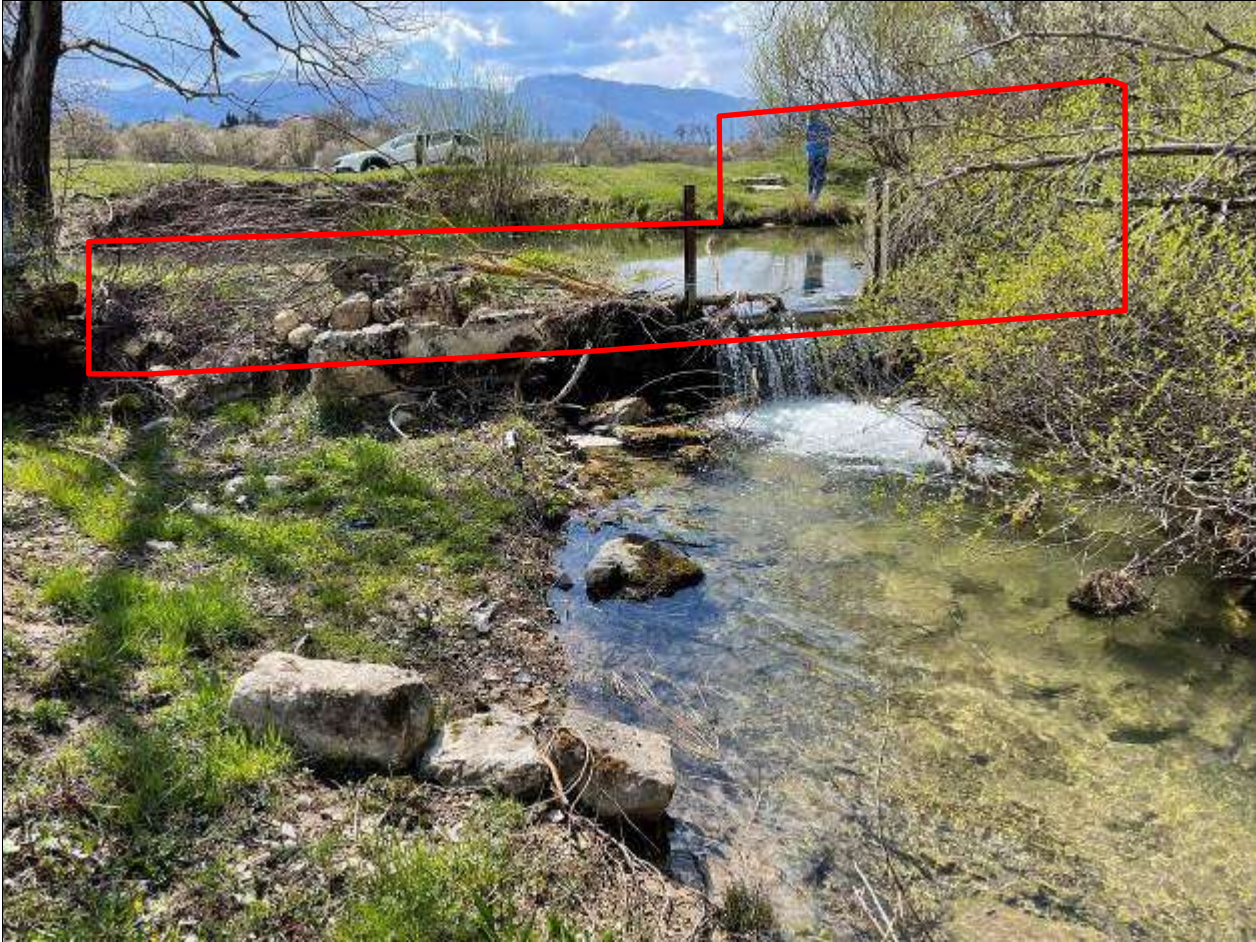
Figure 44..

For redirecting the water flow, excavation and setting up a drainage channel were carried out. This process involved cleaning the channel bed and depositing the excavated gravelly-sandy material along its right bank. This practice led to the formation of an embankment serving as water protection, preventing the overflow of water from the drainage channel. To fortify the embankment, a concrete wall was built on its outer side, measuring approximately 8.0 meters in total length. The earthen embankment has been covered with woody vegetation such as willows, birches, and sporadic instances of oak (as shown in Figure 44).

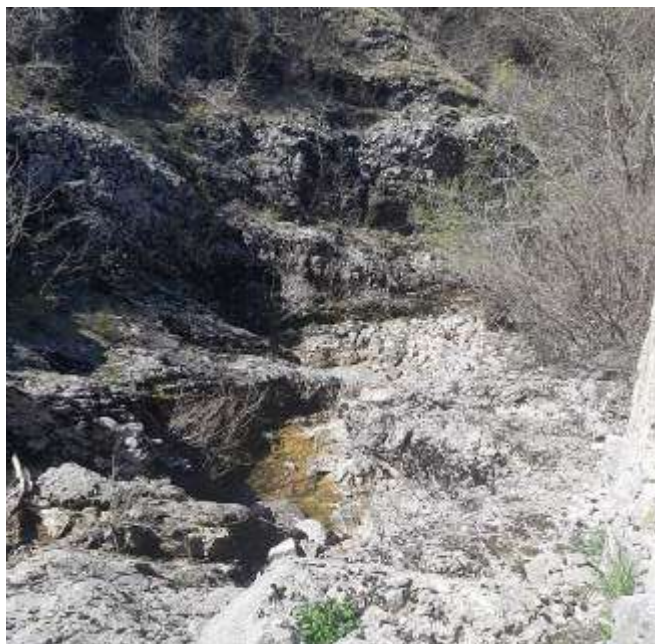
Čaića ponor is located in southern west part of Livanjsko polje (Figure 9) and it collects water from the River Plovuča. River Plovuča is formed by the joining rivers Sturba, Bistrica and Žabljak. It flows through the Livanjsko polje and then sinks in the location of Čaića ponor.

Figure 9. Čaića ponor¹³

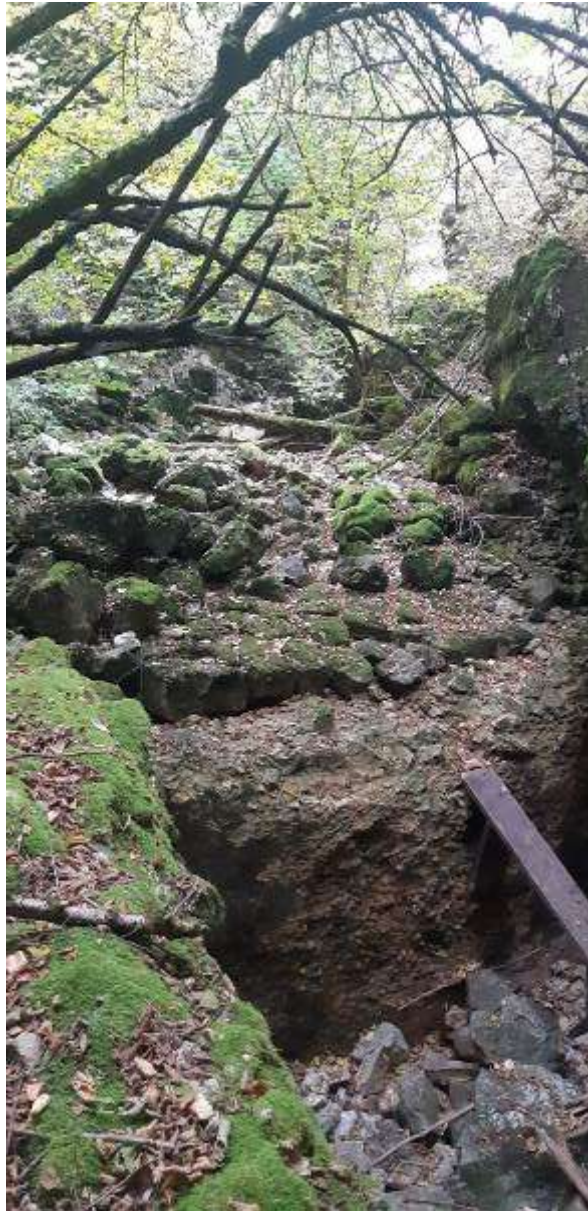
At the very entrance to the abyss we identified one more barrier (Figure 11) that looks like concrete wall. It is assumed that the barrier dates back to Austro-Hungarian era. By the look of it from biological side, this barrier prevents fish to migrate back to the surface waters unless the level of water is very high. In low levels of water fish species are forced to stay in this small area on the entrance of the abyss.

Figure 11. Barrier in the very entrance of the Čaića ponor¹⁵
